DEPARTMENT OF TRANSPORTATION

Quality Assurance and Source Inspection

Contract #: 04-0120F4Cty: SF/ALA Rte: 80 PM: 13.2/13.9File #: 1x.28**WELDING INSPECTION REPORT****Resident Engineer:** Pursell, Gary**Address:** 333 Burma Road**City:** Oakland, CA 94607**Report No:** WIR-012998**Date Inspected:** 14-Apr-2010**Project Name:** SAS Superstructure**OSM Arrival Time:** 1100**Prime Contractor:** American Bridge/Fluor Enterprises, a JV**OSM Departure Time:** 1930**Contractor:** American Bridge/Fluor Enterprises, a JV**Location:** Job Site

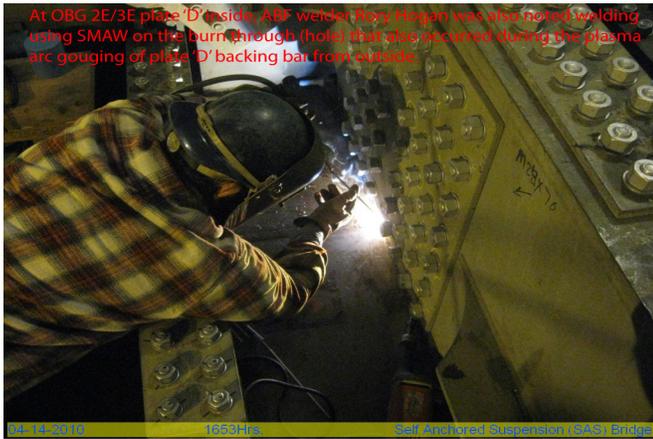
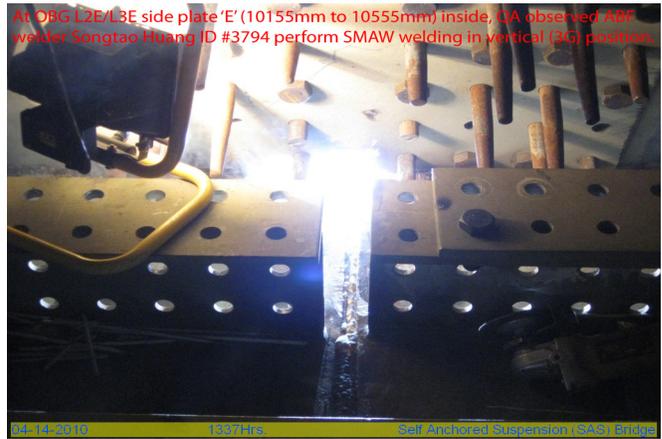
area, the welder also welded the burn through (hole) that occurred during the plasma arc gouging of plate 'D' backing bar. The welder was noted using the same process in flat (1G) position. Backing bar was also put in place at the opposite side of the plate before welding and the hole was ground/cleaned using a die grinder. ABF QC Tom Pasqualone was noted monitoring the welder and welding parameters

At the other end of same plate 'D' (inside) mentioned above, another ABF welder Rory Hogan was also noted welding using SMAW on the burn through (hole) that also occurred during the plasma arc gouging of plate 'D' backing bar. The welder was noted using E7018H4R, 1/8" diameter electrode. Backing bar was also put in place at the opposite side of the plate before welding and the hole was ground/cleaned using a die grinder. ABF QC Jim Cunningham was noted monitoring the welder and welding parameters
