Quality Assurance and Source Inspection

Contract #: 04-0120F4Cty: SF/ALA Rte: 80 PM: 13.2/13.9File #: 69.28**WELDING INSPECTION REPORT****Resident Engineer:** Pursell, Gary**Address:** 333 Burma Road**City:** Oakland, CA 94607**Report No:** WIR-013016**Date Inspected:** 02-Apr-2010**Project Name:** SAS Superstructure**OSM Arrival Time:** 1900**Prime Contractor:** American Bridge/Fluor Enterprises, a JV**OSM Departure Time:** 700**Contractor:** Zhenhua Port Machinery Company, Ltd (ZPMC), Changxing Island **Location:** Shanghai, China**CWI Name:** See Below**CWI Present:** Yes No**Inspected CWI report:** Yes No N/A**Rod Oven in Use:** Yes No N/A**Electrode to specification:** Yes No N/A**Weld Procedures Followed:** Yes No N/A**Qualified Welders:** Yes No N/A**Verified Joint Fit-up:** Yes No N/A**Approved Drawings:** Yes No N/A**Approved WPS:** Yes No N/A**Delayed / Cancelled:** Yes No N/A**Bridge No:** 34-0006**Component:** OBG**Summary of Items Observed:**

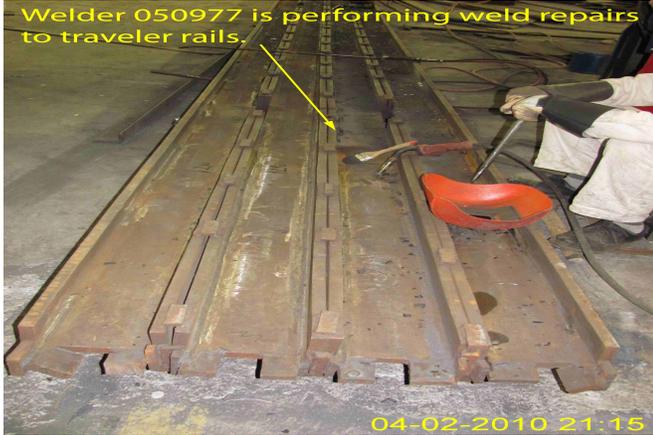
procedure WPS-345-FCAW-1G(1F)-Repair-1 to make weld repairs of traveler rail 20TR2-013-015 in accordance with weld repair document BWR11160. This QA Inspector observed ZPMC QC Inspector Mr. Guo Yuan Ting is monitoring this welding and that Mr. Cheng Yueying is certified to make this weld. This QA Inspector observed a welding current of approximately 300 amps and 31.6 volts. Items observed on this date appeared to generally comply with applicable contract documents.
