DEPARTMENT OF TRANSPORTATION

Quality Assurance and Source Inspection

Contract #: 04-0120F4Cty: SF/ALA Rte: 80 PM: 13.2/13.9File #: 69.28**WELDING INSPECTION REPORT****Resident Engineer:** Pursell, Gary**Address:** 333 Burma Road**City:** Oakland, CA 94607**Report No:** WIR-013040**Date Inspected:** 12-Apr-2010**Project Name:** SAS Superstructure**OSM Arrival Time:** 700**Prime Contractor:** American Bridge/Fluor Enterprises, a JV**OSM Departure Time:** 1900**Contractor:** Zhenhua Port Machinery Company, Ltd (ZPMC), Changxing Island **Location:** Shanghai, China**CWI Name:** Mr. Gong Liang Zhu**CWI Present:** Yes No**Inspected CWI report:** Yes No N/A**Rod Oven in Use:** Yes No N/A**Electrode to specification:** Yes No N/A**Weld Procedures Followed:** Yes No N/A**Qualified Welders:** Yes No N/A**Verified Joint Fit-up:** Yes No N/A**Approved Drawings:** Yes No N/A**Approved WPS:** Yes No N/A**Delayed / Cancelled:** Yes No N/A**Bridge No:** 34-0006**Component:** Tower**Summary of Items Observed:**

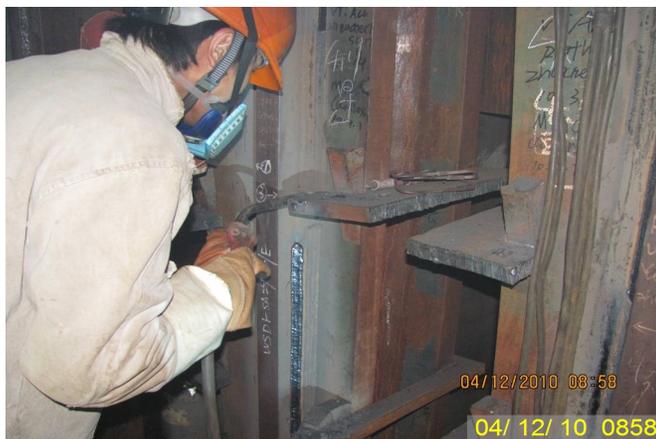
2. This QA inspector, Baskar Govindarajan, observed, ZPMC qualified welding personnel identified as 205649 perform FCAW welding on, Internal, exterior bearing stiffener on West tower, Skin B and Weld joint identified as WSD1-SA279-13. ZPMC CWI Identified as Mr. Gong Linag Zhu. The welding parameters as measured using QC's calibrated instruments appeared to be in general compliance with WPS-B-T-2333-TC-P4-F. (Photo attached)

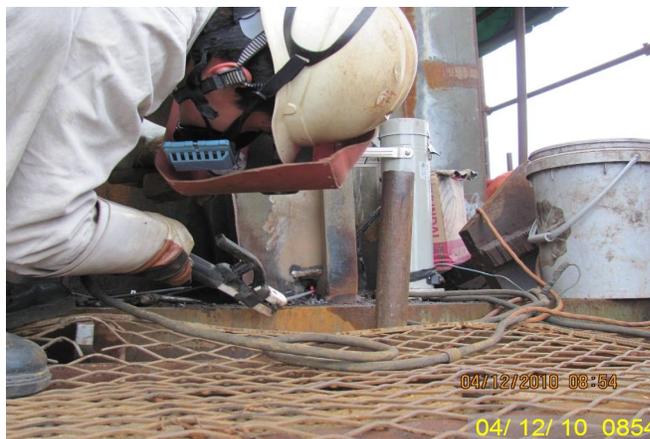
5. This QA inspector, Baskar Govindarajan, observed, ZPMC qualified welding personnel identified as 040675 perform SMAW surface repair welding on, West tower Skin D Bearing stiffener and weld joint identified as WSD1-SA 294 F/G-70. ZPMC CWI Identified as Mr. Gong Liang Zhu. The welding parameters as measured using QC's calibrated instruments appeared to be in general compliance with WPS-345-SMAW-3G (3F)-Repair. (Photo attached)
