DEPARTMENT OF TRANSPORTATION

Quality Assurance and Source Inspection

Contract #: 04-0120F4Cty: SF/Ala Rte: 80 PM: 13.2/13.9File #: 69.28**WELDING INSPECTION REPORT****Resident Engineer:** Pursell, Gary**Address:** 333 Burma Road**City:** Oakland, CA 94607**Report No:** WIR-013104**Date Inspected:** 26-Mar-2010**Project Name:** SAS Superstructure**OSM Arrival Time:** 1900**Prime Contractor:** American Bridge/Fluor Enterprises, a JV**OSM Departure Time:** 700**Contractor:** Zhenhua Port Machinery Company, Ltd (ZPMC), Changxing Island **Location:** Shanghai, China**CWI Name:** See below**CWI Present:** Yes No**Inspected CWI report:** Yes No N/A**Rod Oven in Use:** Yes No N/A**Electrode to specification:** Yes No N/A**Weld Procedures Followed:** Yes No N/A**Qualified Welders:** Yes No N/A**Verified Joint Fit-up:** Yes No N/A**Approved Drawings:** Yes No N/A**Approved WPS:** Yes No N/A**Delayed / Cancelled:** Yes No N/A**Bridge No:** 34-0006**Component:** Tower Components**Summary of Items Observed:**

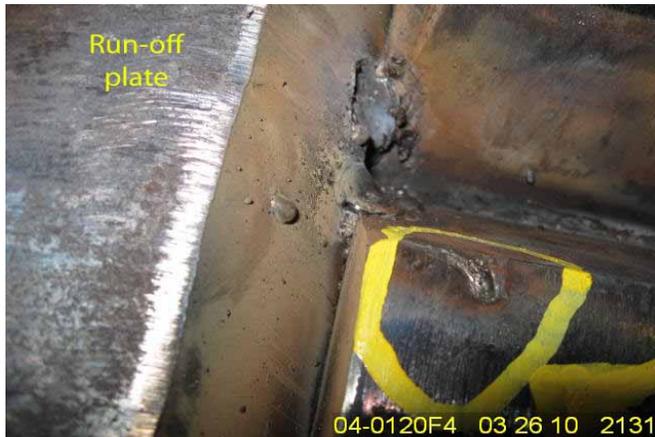
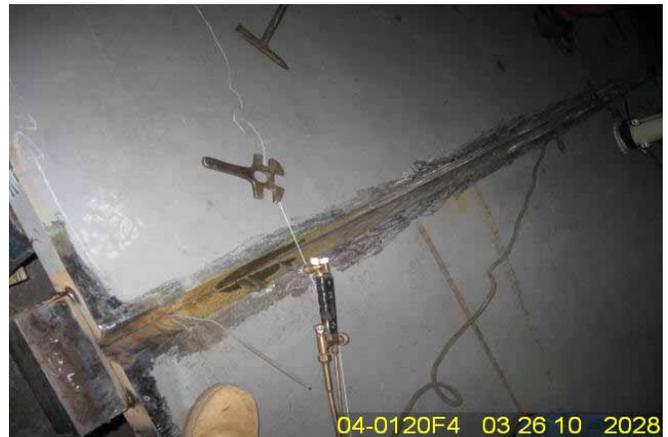
Fit-up and SMAW tack welding of run-off plates at weld joint ESD1-TL5-2B/F-20A located on PCMK east tower, lift 5. Welder was not identified except possibly by a number written into the weld identification area. The number was 203272. When this QA Inspector approached the work site, observed an oxy-fuel torch not connected to a supply hose, and began questioning the ZPMC QC Inspector about preheat requirements, the entire crew

abruptly left the area, including the QC Inspector, who was also unidentified and not recognized by this QA Inspector. This QA Inspector observed an arc strike near one of the two run-off plates and marked it with yellow paint for further magnetic particle inspection. See photos below. No apparent ZPMC CWI's or ABF representatives were in the area.
