DEPARTMENT OF TRANSPORTATION

Contract #: 04-0120F4Cty: SF/ALA Rte: 80 PM: 13.2/13.9File #: 69.28**WELDING INSPECTION REPORT****Resident Engineer:** Pursell, Gary**Address:** 333 Burma Road**City:** Oakland, CA 94607**Report No:** WIR-013187**Date Inspected:** 24-Mar-2010**Project Name:** SAS Superstructure**OSM Arrival Time:** 700**Prime Contractor:** American Bridge/Fluor Enterprises, a JV**OSM Departure Time:** 1900**Contractor:** Zhenhua Port Machinery Company, Ltd (ZPMC), Changxing Island **Location:** Shanghai, China**CWI Name:** Li Yang**CWI Present:** Yes No**Inspected CWI report:** Yes No N/A**Rod Oven in Use:** Yes No N/A**Electrode to specification:** Yes No N/A**Weld Procedures Followed:** Yes No N/A**Qualified Welders:** Yes No N/A**Verified Joint Fit-up:** Yes No N/A**Approved Drawings:** Yes No N/A**Approved WPS:** Yes No N/A**Delayed / Cancelled:** Yes No N/A**Bridge No:** 34-0006**Component:** OBG**Summary of Items Observed:**

OBG Assembly Yard

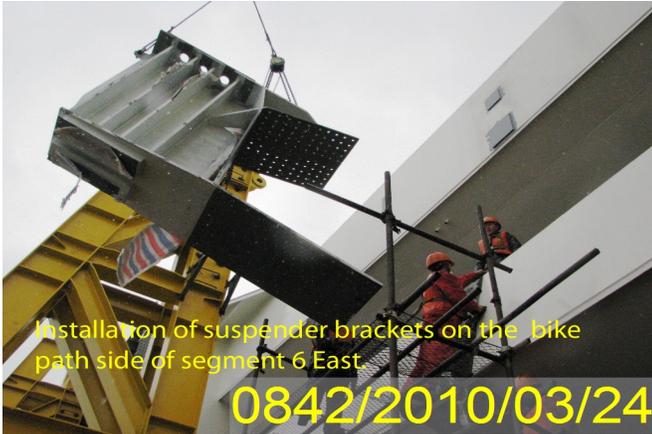
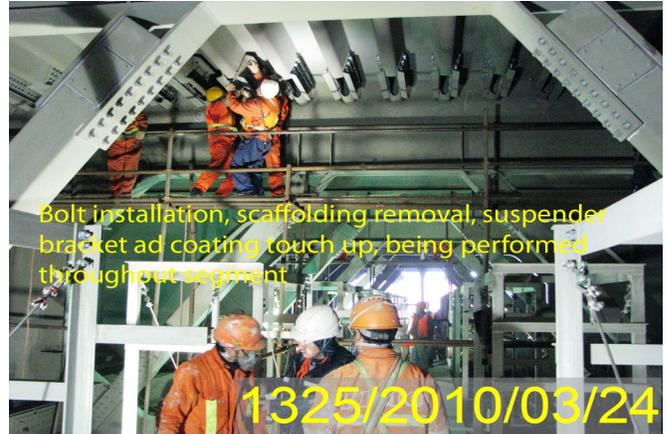
Shield Metal Arc Welding (SMAW) welding was performed on weld joint 020 located at DP662-001 bike path side of segment. Welder is identified as Mr. Dai Lu (048659). ZPMC QC is identified as Li Yang. The welding variables monitored and recorded by the QC appeared to comply with WPS-485-SMAW-3G (3F)-FCM-Repair-1 and WR11321 repair procedure.

Shield Metal Arc Welding (SMAW) VT repair welding was performed on various t stiffeners located on the side plate at bike path side of segment. Welder is identified as Mr. Hu Yanming (062092). ZPMC QC is identified as Li Yang. The welding variables monitored and recorded by the QC appeared to comply with WPS-345-SMAW-2G (2F)-Repair-1.
