DEPARTMENT OF TRANSPORTATION

Contract #: 04-0120F4Cty: SF/ALA Rte: 80 PM: 13.2/13.9File #: 1.28**WELDING INSPECTION REPORT****Resident Engineer:** Pursell, Gary**Address:** 333 Burma Road**City:** Oakland, CA 94607**Report No:** WIR-013196**Date Inspected:** 20-Apr-2010**Project Name:** SAS Superstructure**OSM Arrival Time:** 1100**Prime Contractor:** American Bridge/Fluor Enterprises, a JV**OSM Departure Time:** 1930**Contractor:** American Bridge/Fluor Enterprises, a JV**Location:** Job Site**CWI Name:** Listed below.**CWI Present:** Yes No**Inspected CWI report:** Yes No N/A**Rod Oven in Use:** Yes No N/A**Electrode to specification:** Yes No N/A**Weld Procedures Followed:** Yes No N/A**Qualified Welders:** Yes No N/A**Verified Joint Fit-up:** Yes No N/A**Approved Drawings:** Yes No N/A**Approved WPS:** Yes No N/A**Delayed / Cancelled:** Yes No N/A**Bridge No:** 34-0006**Component:** Orthotropic Box Girders (OBG)**Summary of Items Observed:**

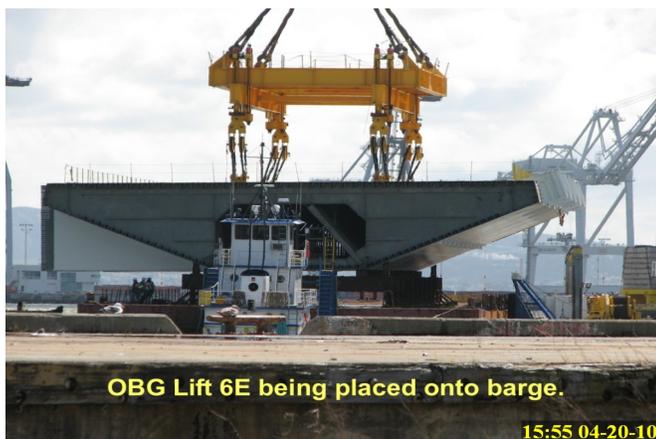
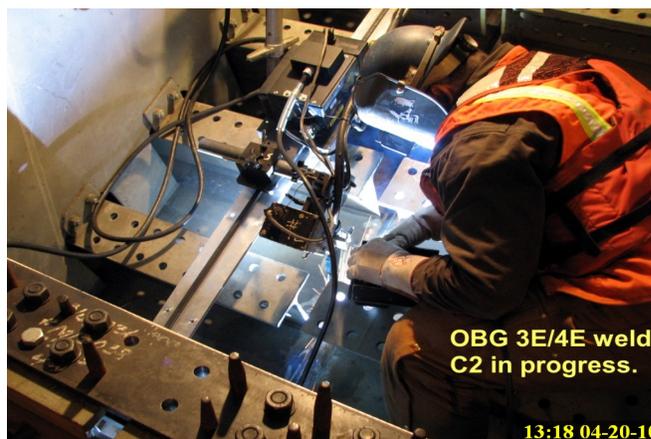
The QAI also noted that the 2nd shipment of OBG segments (lifts 5E, 6E, 5W, 6W and associated cross beams) is being unloaded from the ZPMC transport ship and the segments are being placed on the dock and assorted barges. See the attached photo. The QAI noted that the receiving inspection has not been performed at this time.
