Contract #: 04-0120F4Cty: SF/ALA Rte: 80 PM: 13.2/13.9File #: 1x.28**WELDING INSPECTION REPORT****Resident Engineer:** Pursell, Gary**Address:** 333 Burma Road**City:** Oakland, CA 94607**Report No:** WIR-013215**Date Inspected:** 21-Apr-2010**Project Name:** SAS Superstructure**OSM Arrival Time:** 1000**Prime Contractor:** American Bridge/Fluor Enterprises, a JV**OSM Departure Time:** 1830**Contractor:** American Bridge/Fluor Enterprises, a JV**Location:** Job Site

CWI Name:	Jim Cunningham and Bonifacio Daquinag			CWI Present:	Yes	No	
Inspected CWI report:	Yes	No	N/A	Rod Oven in Use:	Yes	No	N/A
Electrode to specification:	Yes	No	N/A	Weld Procedures Followed:	Yes	No	N/A
Qualified Welders:	Yes	No	N/A	Verified Joint Fit-up:	Yes	No	N/A
Approved Drawings:	Yes	No	N/A	Approved WPS:	Yes	No	N/A
				Delayed / Cancelled:	Yes	No	N/A
Bridge No:	34-0006			Component:	Orthotropic Box Girder

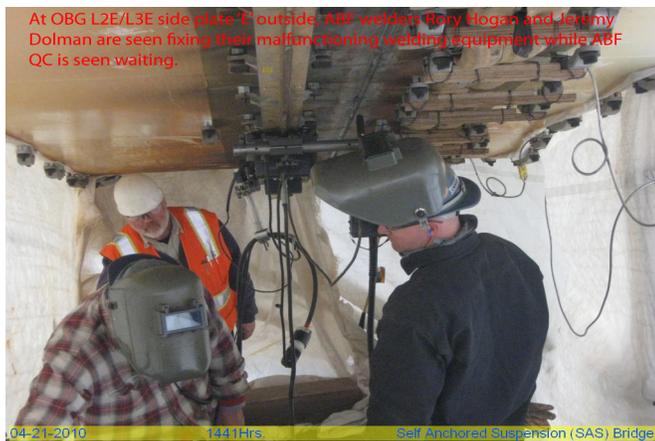
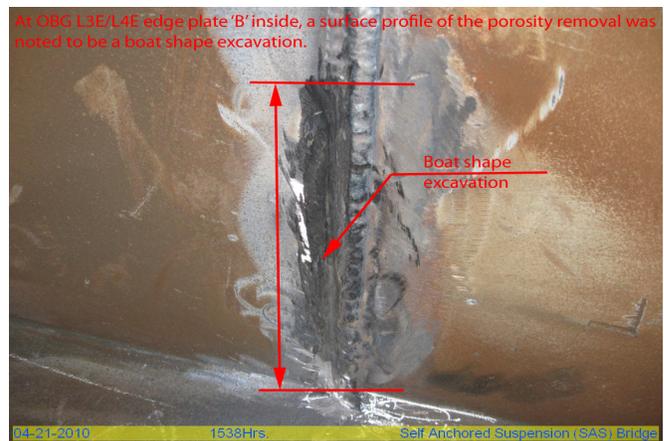
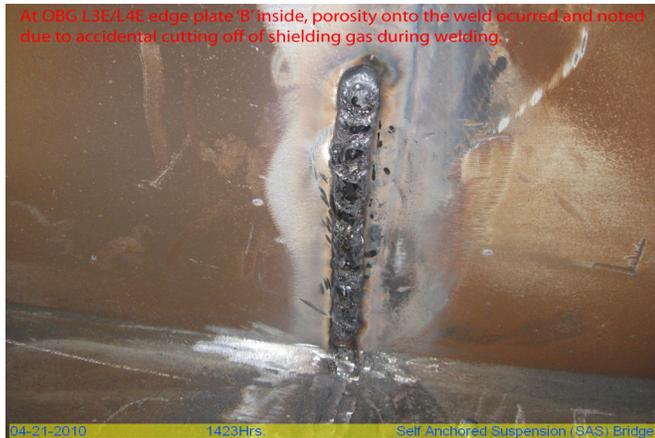
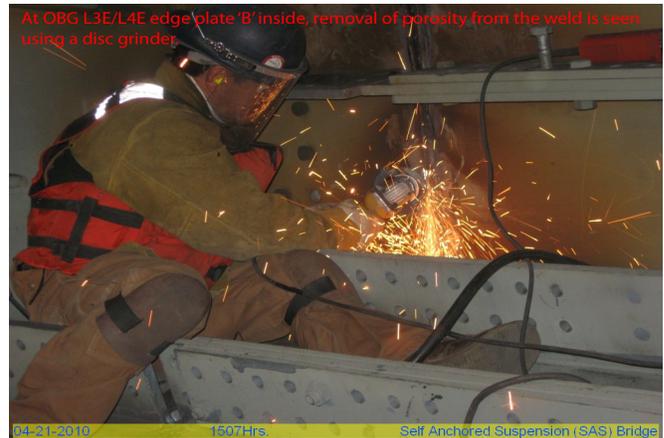
At OBG L3E/L4E plate 'B' (outside), QA randomly observed ABF/JV qualified welder James Zhen ID #6001 perform CJP groove (splice) back welding fill to cover pass. The welder was observed welding in the 3G (vertical) position utilizing a manual dual shield Flux Cored Arc Welding (FCAW-G) with E71T-1M, 1/16" diameter wire electrode and implementing Caltrans approved Welding Procedure Specification (WPS) ABF-WPS-D15-3110-3. The joint being welded has the backing bar gouged using the Esab Plasma Arc machine and was ground smooth. The gouged and ground splice butt joint was also Non Destructive Testing (NDT) tested using the Magnetic Particle Testing (MT). The splice joint was preheated and maintained to greater than 200 degree Fahrenheit using Miller Proheat 35 Induction Heating System located at the other side of the plate prior/during welding. During welding, ABF Quality Control (QC) Bonifacio Daquinag was noted monitoring the welding parameters of the welder. The ABF welder was having porosity in his weld during fill pass and this was attributed to the accidental cutting off of supply of shielding gas. QC has instructed the welder to grind off/remove the porosity in the weld pass while other ABF personnel was fixing the gas problem. After completing grinding, QC have visually inspected and performed Magnetic Particle Testing (MT) on the ground/removal of porosity and accepted. This QA confirmed the acceptance of the ground/removal of porosity. Welding parameters measured during welding were 225 amperes and 23.4 voltages which appear in compliance to the contract requirements.

QA randomly observed ABF/JV qualified welders Rory Hogan (ID #3186) and Jeremy Dolman (ID #5042) perform CJP groove (splice) back welding fill to cover pass on Orthotropic Box Girder (OBG) L2E/L3E plate 'E'(7755mm to 10555mm / outside). The welders were observed welding in the 4G (overhead) position utilizing a dual shield Flux Cored Arc Welding (FCAW-G) with E71T-1M, 1/16" diameter wire electrode and implementing Caltrans approved Welding Procedure Specification (WPS) ABF-WPS-D15-3110-4. The welder was using a track mounted welder holder assembly that is remotely controlled. The joint being welded has the backing bar gouged using the Esab Plasma Arc machine and was ground smooth. The gouged and ground splice butt joint was also Non Destructive Testing (NDT) tested using the Magnetic Particle Testing (MT). The splice joint was preheated and maintained to greater than 150 degree Fahrenheit using Miller Proheat 35 Induction Heating System located at the other side of the plate prior/during welding and the vicinity was properly protected from wind. During welding, ABF Quality Control (QC) Jim Cunningham was noted monitoring the welding parameters of the welder. During the shift, ABF welders were having problem with their welding machine and it took a while before their machine was fixed. At the end of the shift, welding in this location was still continuing.
