**DEPARTMENT OF TRANSPORTATION**

Contract #: 04-0120F4Cty: SF/ALA Rte: 80 PM: 13.2/13.9File #: 69.28**WELDING INSPECTION REPORT****Resident Engineer:** Pursell, Gary**Address:** 333 Burma Road**City:** Oakland, CA 94607**Report No:** WIR-013228**Date Inspected:** 26-Mar-2010**Project Name:** SAS Superstructure**OSM Arrival Time:** 700**Prime Contractor:** American Bridge/Fluor Enterprises, a JV**OSM Departure Time:** 1900**Contractor:** Zhenhua Port Machinery Company, Ltd (ZPMC), Changxing Island **Location:** Shanghai, China

# WELDING INSPECTION REPORT

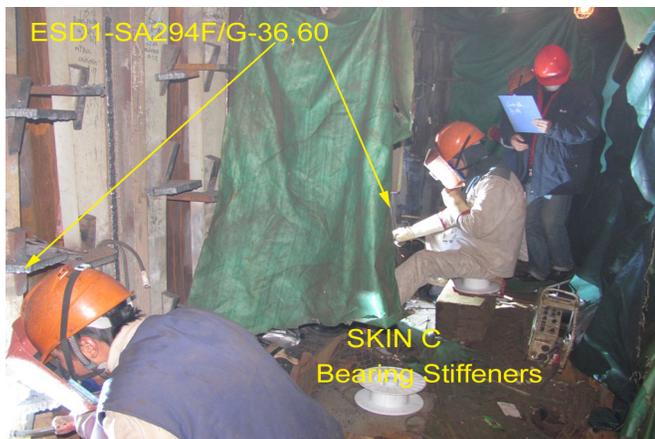
FCAW welding of weld joint no: ESD1-SA294F/G-36 located on Skin C Bearing Stiffener. Welder is identified as 205649. ZPMC QC is identified as Mr. Xing shi shun. The welding variables recorded by QC appeared to comply with the WPS-B-T-2333-TC-P4-F. Please see the attached picture.
