**DEPARTMENT OF TRANSPORTATION**

Contract #: 04-0120F4Cty: SF/ALA Rte: 80 PM: 13.2/13.9File #: 69.28**WELDING INSPECTION REPORT****Resident Engineer:** Pursell, Gary**Address:** 333 Burma Road**City:** Oakland, CA 94607**Report No:** WIR-013231**Date Inspected:** 03-Mar-2010**Project Name:** SAS Superstructure**OSM Arrival Time:** 700**Prime Contractor:** American Bridge/Fluor Enterprises, a JV**OSM Departure Time:** 1900**Contractor:** Zhenhua Port Machinery Company, Ltd (ZPMC), Changxing Island **Location:** Shanghai, China**CWI Name:** Du Zhi Qun**CWI Present:** Yes No**Inspected CWI report:** Yes No N/A**Rod Oven in Use:** Yes No N/A**Electrode to specification:** Yes No N/A**Weld Procedures Followed:** Yes No N/A**Qualified Welders:** Yes No N/A**Verified Joint Fit-up:** Yes No N/A**Approved Drawings:** Yes No N/A**Approved WPS:** Yes No N/A**Delayed / Cancelled:** Yes No N/A**Bridge No:** 34-0006**Component:** Tower**Summary of Items Observed:**

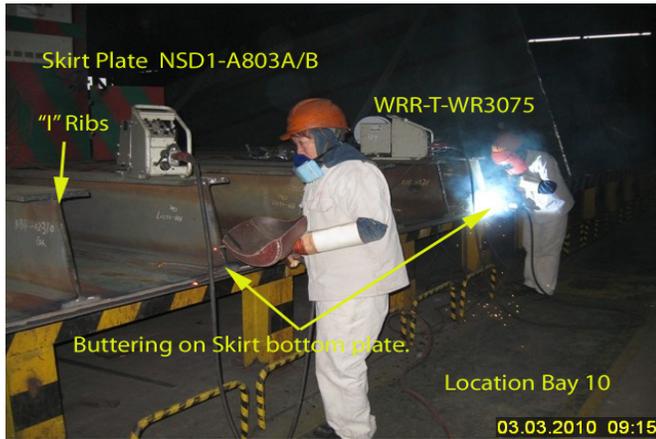
This QA Inspector observed ZPMC qualified welding personnel identified as 054069, 052075 Perform Flux Core Arc Welding (FCAW) on Skirt Plate, Buttering up to 3~9mm on Skirt Plate, NSD1-A803A/B I rib and bottom plate 803, ZPMC QC Identified as Jiang Xiang Bo. With Temporary welding repair report, WRR-T-WR3075, The welding parameters as measured using QC's calibrated instrument appeared to be in general compliance with WPS-345-FCAW-2G(2F) Repair. For more information see below attached photo.
