Contract #: 04-0120F4Cty: SF/ALA Rte: 80 PM: 13.2/13.9File #: 69.28**WELDING INSPECTION REPORT****Resident Engineer:** Pursell, Gary**Address:** 333 Burma Road**City:** Oakland, CA 94607**Report No:** WIR-013245**Date Inspected:** 22-Mar-2010**Project Name:** SAS Superstructure**OSM Arrival Time:** 700**Prime Contractor:** American Bridge/Fluor Enterprises, a JV**OSM Departure Time:** 1900**Contractor:** Zhenhua Port Machinery Company, Ltd (ZPMC), Changxing Island **Location:** Shanghai, China**CWI Name:** Zhao Chen Sun**CWI Present:** Yes No**Inspected CWI report:** Yes No N/A**Rod Oven in Use:** Yes No N/A**Electrode to specification:** Yes No N/A**Weld Procedures Followed:** Yes No N/A**Qualified Welders:** Yes No N/A**Verified Joint Fit-up:** Yes No N/A**Approved Drawings:** Yes No N/A**Approved WPS:** Yes No N/A**Delayed / Cancelled:** Yes No N/A**Bridge No:** 34-0006**Component:** Tower Trial Assembly**Summary of Items Observed:**

TOWER TRIAL ASSEMBLY:

WELDING INSPECTION REPORT

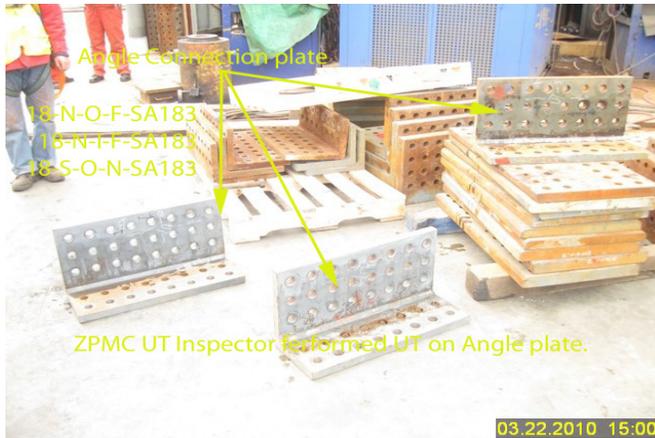
This QA Inspector observed during random Visual inspection, ZPMC Ultrasonic Testing (UT) Inspector performed UT on Angle connection plate. For more information see below attached photo.
