**DEPARTMENT OF TRANSPORTATION**

Contract #: 04-0120F4Cty: SF/ALA Rte: 80 PM: 13.2/13.9File #: 69.28**WELDING INSPECTION REPORT****Resident Engineer:** Pursell, Gary**Address:** 333 Burma Road**City:** Oakland, CA 94607**Report No:** WIR-013277**Date Inspected:** 16-Feb-2010**Project Name:** SAS Superstructure**OSM Arrival Time:** 700**Prime Contractor:** American Bridge/Fluor Enterprises, a JV**OSM Departure Time:** 1900**Contractor:** Zhenhua Port Machinery Company, Ltd (ZPMC), Changxing Island **Location:** Shanghai, China**CWI Name:** Du Zhi Qun, Li Lin**CWI Present:** Yes No**Inspected CWI report:** Yes No N/A**Rod Oven in Use:** Yes No N/A**Electrode to specification:** Yes No N/A**Weld Procedures Followed:** Yes No N/A**Qualified Welders:** Yes No N/A**Verified Joint Fit-up:** Yes No N/A**Approved Drawings:** Yes No N/A**Approved WPS:** Yes No N/A**Delayed / Cancelled:** Yes No N/A**Bridge No:** 34-0006**Component:** Tower**Summary of Items Observed:**

# WELDING INSPECTION REPORT

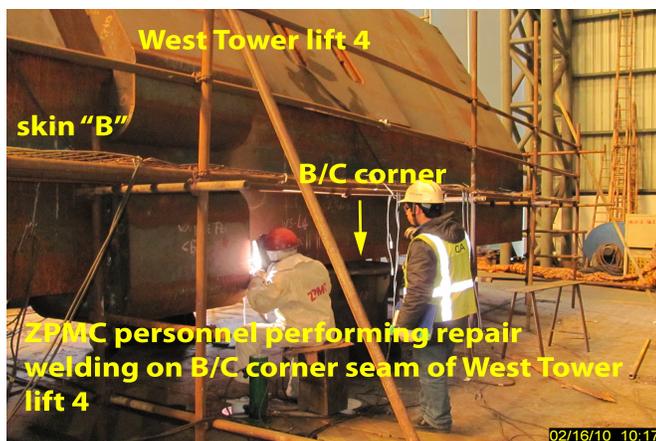
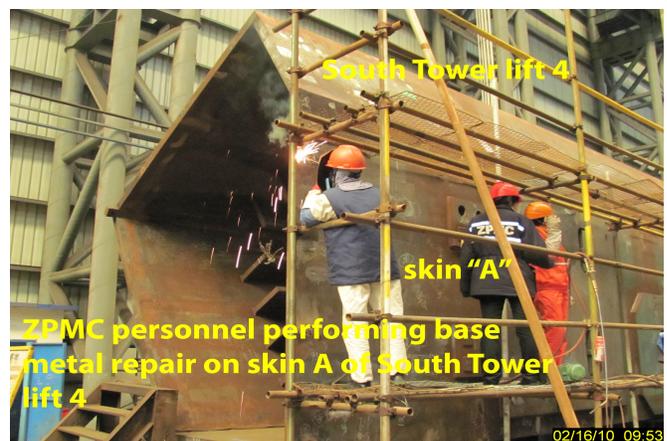
## SOUTH TOWER LIFT 4, BASE METAL REPAIR

During random in process Visual Inspection this Quality Assurance (QA) Inspector observed that ZPMC personnel performing base metal repair welding on skin A of South Tower lift 4. Welder is identified as 056364. ZPMC QC is identified as Jiang La Mei. The welding variables recorded by QC appeared to comply with WPS-485-SMAW-2G(2F)-REPAIR-1. Attached photographs provide additional details.
