**DEPARTMENT OF TRANSPORTATION**

Contract #: 04-0120F4Cty: SF/ALA Rte: 80 PM: 13.2/13.9File #: 69.28**WELDING INSPECTION REPORT****Resident Engineer:** Pursell, Gary**Address:** 333 Burma Road**City:** Oakland, CA 94607**Report No:** WIR-013287**Date Inspected:** 09-Mar-2010**Project Name:** SAS Superstructure**OSM Arrival Time:** 700**Prime Contractor:** American Bridge/Fluor Enterprises, a JV**OSM Departure Time:** 1900**Contractor:** Zhenhua Port Machinery Company, Ltd (ZPMC), Changxing Island **Location:** Shanghai, China**CWI Name:** Yu Dong Ping, Tu Jun**CWI Present:** Yes No**Inspected CWI report:** Yes No N/A**Rod Oven in Use:** Yes No N/A**Electrode to specification:** Yes No N/A**Weld Procedures Followed:** Yes No N/A**Qualified Welders:** Yes No N/A**Verified Joint Fit-up:** Yes No N/A**Approved Drawings:** Yes No N/A**Approved WPS:** Yes No N/A**Delayed / Cancelled:** Yes No N/A**Bridge No:** 34-0006**Component:** Tower**Summary of Items Observed:**

## WELDING INSPECTION REPORT

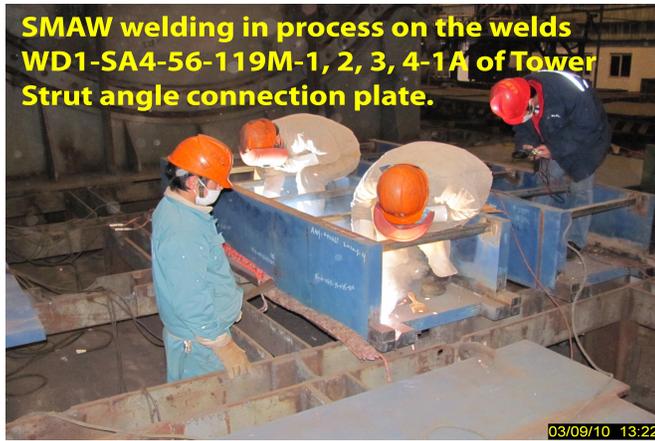
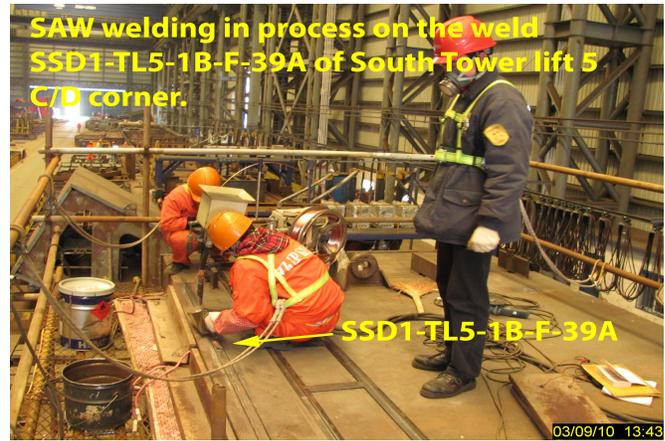
SAW welding of weld joint 21B located on SSD1-TL5-1B-F.

SAW welding of weld joint 39A located on SSD1-TL5-1B-F.

SAW welding of weld joint 3A located on ED1-STSA4-6-131M-1.

SMAW welding of weld joint 1A located on WD1-SA4-56-119M-2.
