DEPARTMENT OF TRANSPORTATION

Quality Assurance and Source Inspection

Contract #: 04-0120F4Cty: SF/ALA Rte: 80 PM: 13.2/13.9File #: 69.28**WELDING INSPECTION REPORT****Resident Engineer:** Pursell, Gary**Address:** 333 Burma Road**City:** Oakland, CA 94607**Report No:** WIR-013455**Date Inspected:** 09-Mar-2010**Project Name:** SAS Superstructure**OSM Arrival Time:** 700**Prime Contractor:** American Bridge/Fluor Enterprises, a JV**OSM Departure Time:** 1900**Contractor:** Zhenhua Port Machinery Company, Ltd (ZPMC), Changxing Island **Location:** Shanghai, China**CWI Name:** Liu hua ji**CWI Present:** Yes No**Inspected CWI report:** Yes No N/A**Rod Oven in Use:** Yes No N/A**Electrode to specification:** Yes No N/A**Weld Procedures Followed:** Yes No N/A**Qualified Welders:** Yes No N/A**Verified Joint Fit-up:** Yes No N/A**Approved Drawings:** Yes No N/A**Approved WPS:** Yes No N/A**Delayed / Cancelled:** Yes No N/A**Bridge No:** 34-0006**Component:** OBG Components**Summary of Items Observed:**

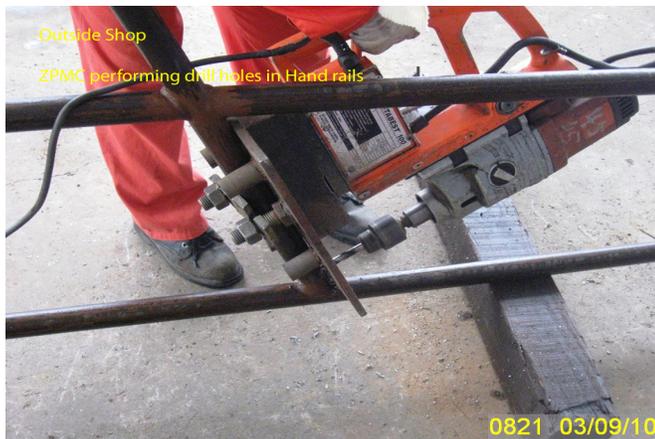
ZPMC make drill holes in Hand rails is appeared to comply with the contract documents.

Outside Shop
ZPMC performing drill holes in Hand rails

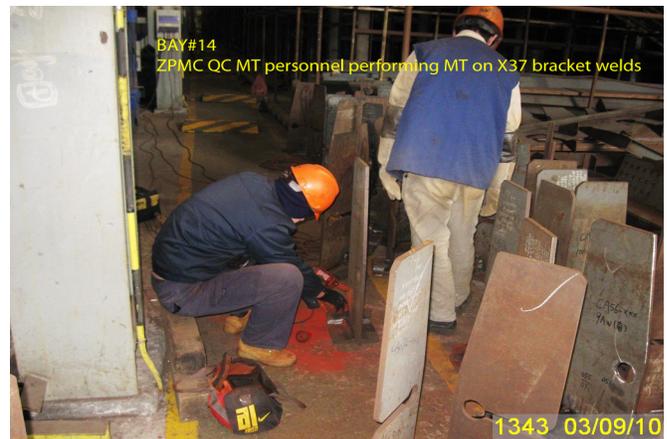
This QA inspector performed MT of approximately 15% of the area previously tested and accepted by ZPMC Quality Control personnel. This QA inspector generated an MT report for this date. The members are identified as X37 bracket plate. The weld designations reviewed are as follows:

BAY#14
ZPMC QC MT personnel performing MT on X37 bracket welds
