Quality Assurance and Source Inspection

Contract #: 04-0120F4Cty: SF/ALA Rte: 80 PM: 13.2/13.9File #: 69.28**WELDING INSPECTION REPORT****Resident Engineer:** Pursell, Gary**Address:** 333 Burma Road**City:** Oakland, CA 94607**Report No:** WIR-013498**Date Inspected:** 29-Apr-2010**Project Name:** SAS Superstructure**OSM Arrival Time:** 700**Prime Contractor:** American Bridge/Fluor Enterprises, a JV**OSM Departure Time:** 1900**Contractor:** Zhenhua Port Machinery Company, Ltd (ZPMC), Changxing Island **Location:** Shanghai, China**CWI Name:** Li Yang**CWI Present:** Yes No**Inspected CWI report:** Yes No N/A**Rod Oven in Use:** Yes No N/A**Electrode to specification:** Yes No N/A**Weld Procedures Followed:** Yes No N/A**Qualified Welders:** Yes No N/A**Verified Joint Fit-up:** Yes No N/A**Approved Drawings:** Yes No N/A**Approved WPS:** Yes No N/A**Delayed / Cancelled:** Yes No N/A**Bridge No:** 34-0006**Component:** OBG**Summary of Items Observed:**

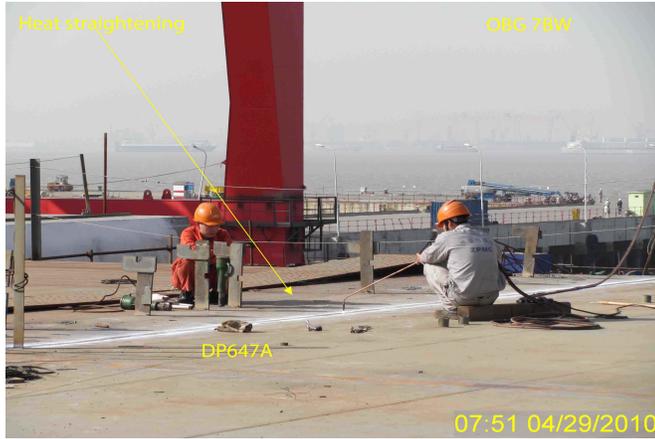
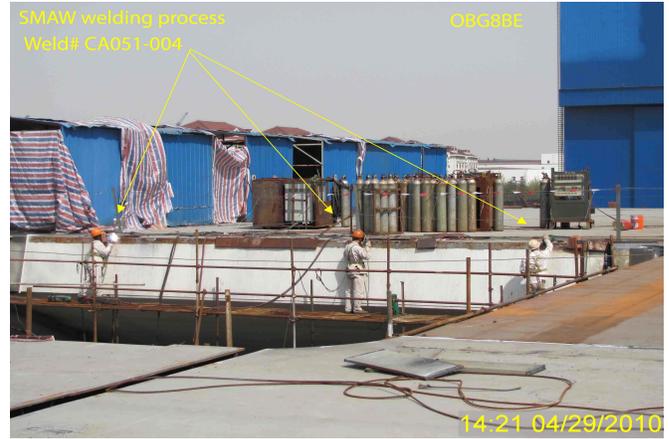
This Quality Assurance (QA) Inspector observed ZPMC qualified welders 067904, 067765, performing Shielded Metal Arc Welding process for weld OBE8C-001 located on PCMK. Side panel splice weld between OBG segment 8BE and 8CE (cross beam side). ZPMC QC Mr. Wang Li Yang monitoring this welding. The welding variables recorded by QC appeared to comply with the WPS-B-P-2214-B-U2-FCM-1.

This Quality Assurance (QA) Inspector observed ZPMC qualified welders 067609, 068764, performing Shielded Metal Arc Welding process for weld OBE8C-002 located on PCMK. Side panel splice weld between OBG segment 8BE and 8CE(cross beam side). ZPMC QC Mr. Wang Li Yang monitoring this welding. The welding variables recorded by QC appeared to comply with the WPS-B-P-2214-B-U2-FCM-1.
