DEPARTMENT OF TRANSPORTATION

Quality Assurance and Source Inspection

Contract #: 04-0120F4Cty: SF/ALA Rte: 80 PM: 13.2/13.9File #: 69.28**WELDING INSPECTION REPORT****Resident Engineer:** Pursell, Gary**Address:** 333 Burma Road**City:** Oakland, CA 94607**Report No:** WIR-013559**Date Inspected:** 01-May-2010**Project Name:** SAS Superstructure**OSM Arrival Time:** 700**Prime Contractor:** American Bridge/Fluor Enterprises, a JV**OSM Departure Time:** 1900**Contractor:** Zhenhua Port Machinery Company, Ltd (ZPMC), Changxing Island **Location:** Shanghai, China**CWI Name:** Yu Dong Ping**CWI Present:** Yes No**Inspected CWI report:** Yes No N/A**Rod Oven in Use:** Yes No N/A**Electrode to specification:** Yes No N/A**Weld Procedures Followed:** Yes No N/A**Qualified Welders:** Yes No N/A**Verified Joint Fit-up:** Yes No N/A**Approved Drawings:** Yes No N/A**Approved WPS:** Yes No N/A**Delayed / Cancelled:** Yes No N/A**Bridge No:** 34-0006**Component:** Tower**Summary of Items Observed:**

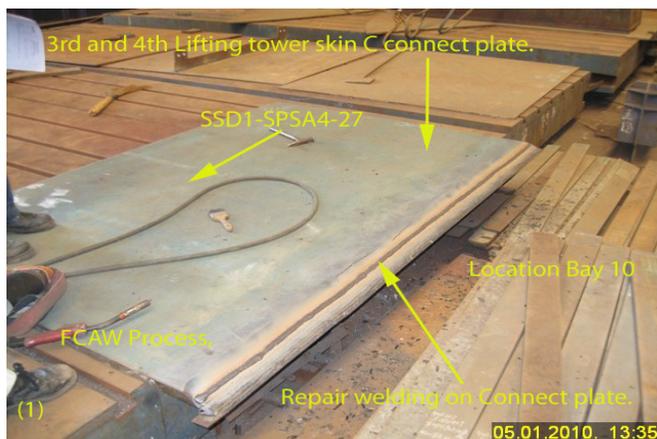
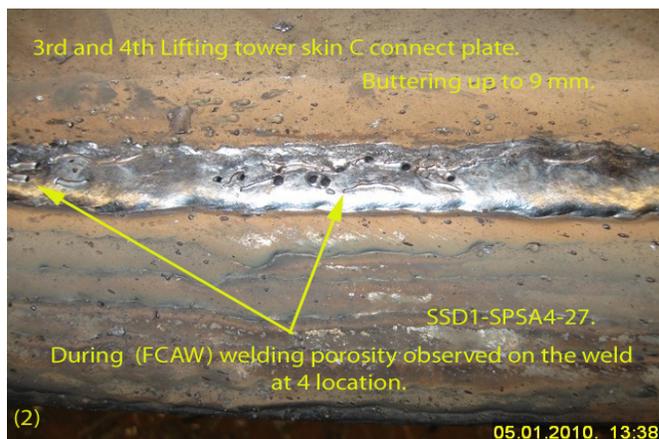
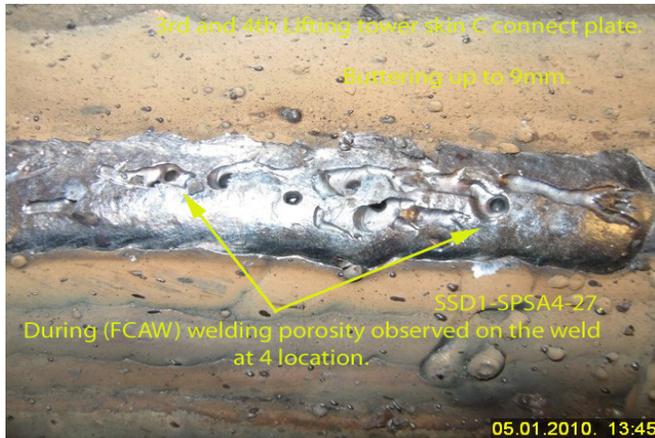
This QA Inspector observed ZPMC qualified welding personnel identified as 057258. Perform Shielded Metal Arc Welding (SMAW) on 3rd and 4th Lifting tower skin C connect plate, Buttering up to 9mm, Plate identified as SSD1-SPSA4-27. ZPMC QC Identified as Zhu Zhong Jie, with Temporary welding repair report. The welding parameters as measured using QC's calibrated instrument appeared to be in general compliance with WPS-345-FCAW-2G (2F)-Repair. For more information see below attach photo.
