Contract #: 04-0120F4Cty: SF/ALA Rte: 80 PM: 13.2/13.9File #: 69.28**WELDING INSPECTION REPORT****Resident Engineer:** Pursell, Gary**Address:** 333 Burma Road**City:** Oakland, CA 94607**Report No:** WIR-013648**Date Inspected:** 28-Apr-2010**Project Name:** SAS Superstructure**OSM Arrival Time:** 1900**Prime Contractor:** American Bridge/Fluor Enterprises, a JV**OSM Departure Time:** 700**Contractor:** Zhenhua Port Machinery Company, Ltd (ZPMC), Changxing Island **Location:** Shanghai, China**CWI Name:** See Below**CWI Present:** Yes No**Inspected CWI report:** Yes No N/A**Rod Oven in Use:** Yes No N/A**Electrode to specification:** Yes No N/A**Weld Procedures Followed:** Yes No N/A**Qualified Welders:** Yes No N/A**Verified Joint Fit-up:** Yes No N/A**Approved Drawings:** Yes No N/A**Approved WPS:** Yes No N/A**Delayed / Cancelled:** Yes No N/A**Bridge No:** 34-0006**Component:** OBG**Summary of Items Observed:**

OBG Bay 7

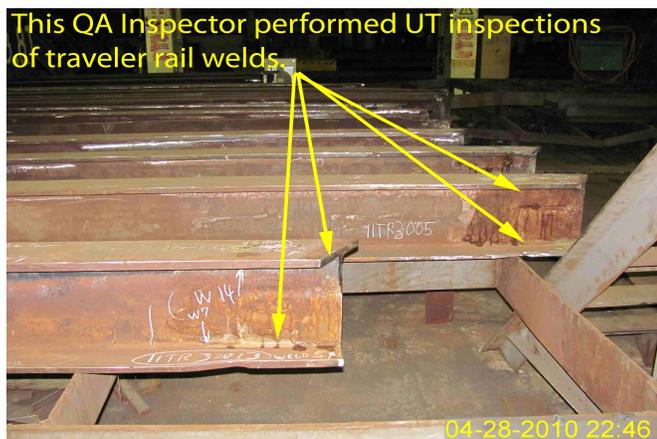
ZPMC issued "Inspection Notification Sheet" number 5623 informing Caltrans QA that ZPMC will perform ultrasonic inspections (UT) of the complete joint penetration welds on fifteen OBG traveler rails that are located in OBG bay7 at 1600 hours today and they will then be ready for Caltrans QA personnel to perform ultrasonic inspections of these welds. This QA Inspector observed ZPMC appears to have UT accepted the traveler rail welds and this QA Inspector performed random visual and ultrasonic inspections of the following welds: 11TR3-018-5, 6, 7, 10, 13, 14; 11TR3-005-5, 6, 7, 10, 13, 14; 11TR3-022-5, 6, 7, 10, 13, 14; 11TR3-007-5, 6, 7, 10, 13, 14; 11TR3-009-5, 6, 7, 10, 13, 14; 11TR3-011-5, 6, 7, 13, 14; 11TR3-006-5, 6, 7, 10, 13, 14 and 11TR3-010-55, 6, 7, 10, 13, 14. Items observed by this QA Inspector appear to comply with AWS D1.5 UT requirements. For additional information on these inspections see the TL6027 Ultrasonic Test Report and the photograph below.
