Contract #: 04-0120F4Cty: SF/Ala Rte: 80 PM: 13.2/13.9File #: 69.28**WELDING INSPECTION REPORT****Resident Engineer:** Pursell, Gary**Address:** 333 Burma Road**City:** Oakland, CA 94607**Report No:** WIR-013711**Date Inspected:** 29-Mar-2010**Project Name:** SAS Superstructure**OSM Arrival Time:** 1900**Prime Contractor:** American Bridge/Fluor Enterprises, a JV**OSM Departure Time:** 700**Contractor:** Zhenhua Port Machinery Company, Ltd (ZPMC), Changxing Island **Location:** Shanghai, China**CWI Name:** See below**CWI Present:** Yes No**Inspected CWI report:** Yes No N/A**Rod Oven in Use:** Yes No N/A**Electrode to specification:** Yes No N/A**Weld Procedures Followed:** Yes No N/A**Qualified Welders:** Yes No N/A**Verified Joint Fit-up:** Yes No N/A**Approved Drawings:** Yes No N/A**Approved WPS:** Yes No N/A**Delayed / Cancelled:** Yes No N/A**Bridge No:** 34-0006**Component:** Tower Components**Summary of Items Observed:**

WELDING INSPECTION REPORT

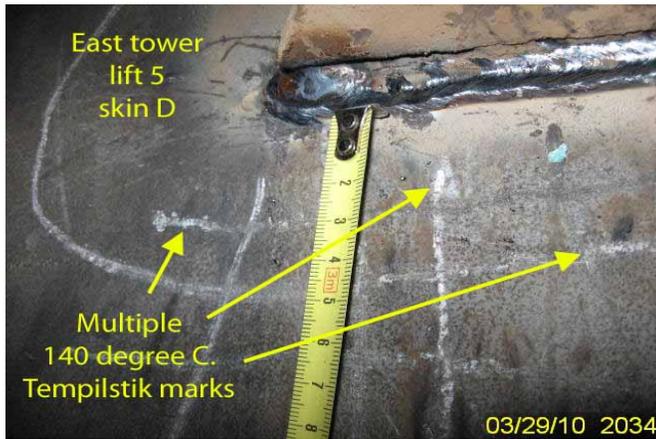
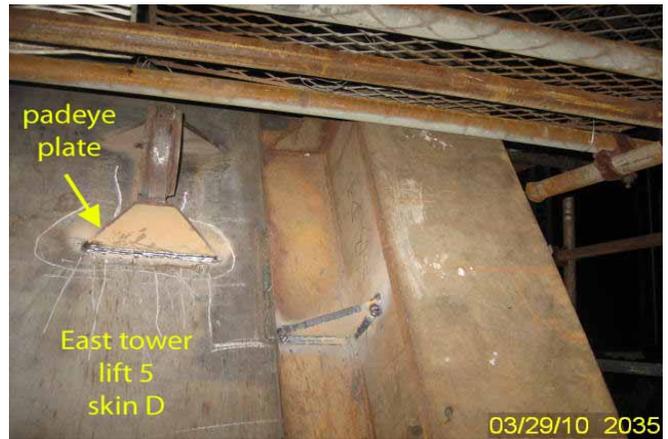
SMAW welding attaching a temporary lifting eye plate to outside PCMK east tower, lift 5, skin D (60 mm thickness), approximately 700mm from bottom of lift 5. Welder was not identified because he left the work area when this QA Inspector began taking photographs. QC was identified as ZPMC CWI Li Lin (QC1). Assisting QC1 at this location and appearing to be monitoring the welding and recording data was ZPMC QC Li Bin, who was not a CWI. The welding variables recorded by QC1's assistant did not appear to comply with WPS-B-T-4114, as noted below.

ZPMC personnel performing shielded metal arc welding, without sufficient base material preheating as follows:

- Multiple 140 degree Celsius Tempilstik temperature indicator marks applied by this QA Inspector to the adjacent base material within approximately 75mm from the point of welding did not melt.
- WPS-B-T-4114 presented to this QA Inspector by ZPMC QC Li Bin is designated for A709M, grade 345 material.

- East tower, lift 5, skin D is designated as A709M, HPS 485W-T2-Z. All previous welding on lift 5 has been performed with a WPS requiring a minimum preheat and interpass temperature of 180° C.

This QA Inspector generated a Caltrans Incident Report, TL15, concerning the above noted issue and informed ZPMC QC Li Bin and ABF Representative Luo Lai Quan of this issue. See the photos below for additional
