DEPARTMENT OF TRANSPORTATION

Quality Assurance and Source Inspection

Contract #: 04-0120F4Cty: SF/ALA Rte: 80 PM: 13.2/13.9File #: 69.28**WELDING INSPECTION REPORT****Resident Engineer:** Pursell, Gary**Address:** 333 Burma Road**City:** Oakland, CA 94607**Report No:** WIR-013756**Date Inspected:** 19-Mar-2010**Project Name:** SAS Superstructure**OSM Arrival Time:** 700**Prime Contractor:** American Bridge/Fluor Enterprises, a JV**OSM Departure Time:** 1900**Contractor:** Zhenhua Port Machinery Company, Ltd (ZPMC), Changxing Island **Location:** Shanghai, China**CWI Name:** Xu Le Feng**CWI Present:** Yes No**Inspected CWI report:** Yes No N/A**Rod Oven in Use:** Yes No N/A**Electrode to specification:** Yes No N/A**Weld Procedures Followed:** Yes No N/A**Qualified Welders:** Yes No N/A**Verified Joint Fit-up:** Yes No N/A**Approved Drawings:** Yes No N/A**Approved WPS:** Yes No N/A**Delayed / Cancelled:** Yes No N/A**Bridge No:** 34-0006**Component:** Tower Components**Summary of Items Observed:**

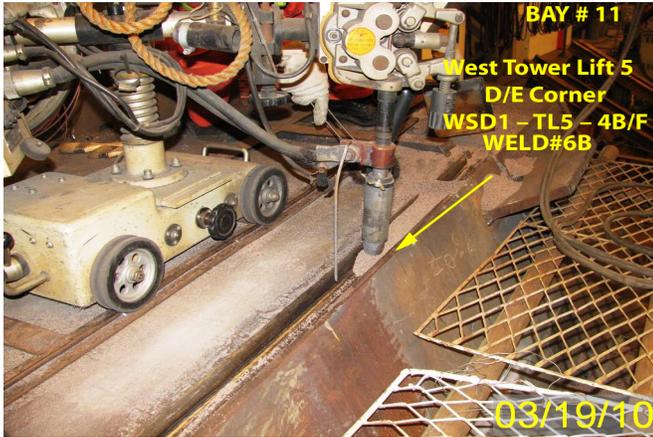
Weld joint # 6B located on West Tower Lift 5 D/E Corner WSD1 – TL5 – 4B/F. Welder is identified as 040699. ZPMC Quality Control (QC) Inspector is identified as Li Jun. The welding variables recorded by QC appeared to comply with the WPS – B – T – 3221 – C – U2b – S. (See attached photo)
