Contract #: 04-0120F4Cty: SF/ALA Rte: 80 PM: 13.2/13.9File #: 13.28**WELDING INSPECTION REPORT****Resident Engineer:** Pursell, Gary**Address:** 333 Burma Road**City:** Oakland, CA 94607**Report No:** WIR-013936**Date Inspected:** 07-May-2010**Project Name:** SAS Superstructure**OSM Arrival Time:** 1000**Prime Contractor:** American Bridge/Fluor Enterprises, a JV**OSM Departure Time:** 1830**Contractor:** Oregon Iron Works Clackamas, Or.**Location:** Clackamas, OR

Bridge No: 34-0006**Component:** Hinge K Pipe Beams**Summary of Items Observed:**

Hinge-K Pipe Beam Assembly 101A-4:

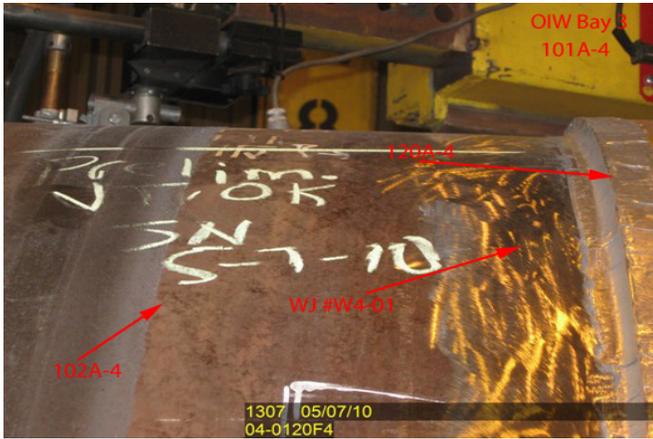
The QA Inspector observed that the grinding flush of the weld cap, on weld joint #W4-01, had been completed on the previous graveyard shift. The QA Inspector observed that OIW QC Inspector Jon Nickolich had performed a preliminary visual inspection on the weld joint and had accepted. The QA Inspector observed that OIW Lead QC Inspector Mike Gregson was present on this shift and QC Inspector Gregson explained that the Magnetic Particle and Ultrasonic testing will be performed on 5/10/10. QC Inspector Gregson explained that the weld had cooled to ambient temperature at 0700, on this date. The QA Inspector noted that per AWS D1.5 Cooling Times Prior to Inspection, a minimum of 72 hrs. is required for final Visual, Ultrasonic and Magnetic Particle testing. See attached picture below.
