**DEPARTMENT OF TRANSPORTATION**

Contract #: 04-0120F4Cty: SF/ALA Rte: 80 PM: 13.2/13.9File #: 1.28**WELDING INSPECTION REPORT****Resident Engineer:** Pursell, Gary**Address:** 333 Burma Road**City:** Oakland, CA 94607**Report No:** WIR-013949**Date Inspected:** 12-May-2010**Project Name:** SAS Superstructure**OSM Arrival Time:** 1100**Prime Contractor:** American Bridge/Fluor Enterprises, a JV**OSM Departure Time:** 1930**Contractor:** American Bridge/Fluor Enterprises, a JV**Location:** Job Site**CWI Name:** See Below**CWI Present:** Yes No**Inspected CWI report:** Yes No N/A**Rod Oven in Use:** Yes No N/A**Electrode to specification:** Yes No N/A**Weld Procedures Followed:** Yes No N/A**Qualified Welders:** Yes No N/A**Verified Joint Fit-up:** Yes No N/A**Approved Drawings:** Yes No N/A**Approved WPS:** Yes No N/A**Delayed / Cancelled:** Yes No N/A**Bridge No:** 34-0006**Component:** Orthotropic Box Girders**Summary of Items Observed:**

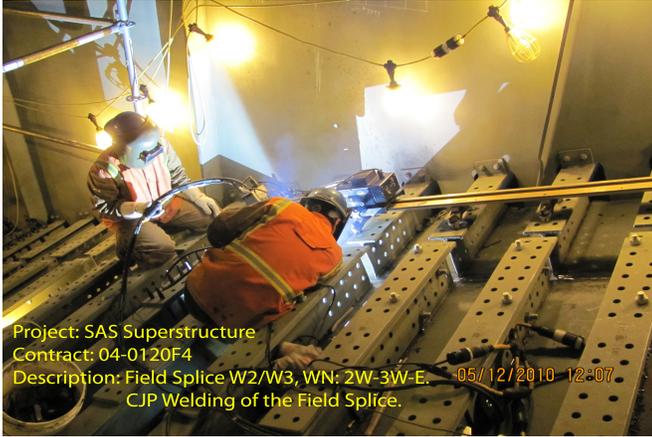
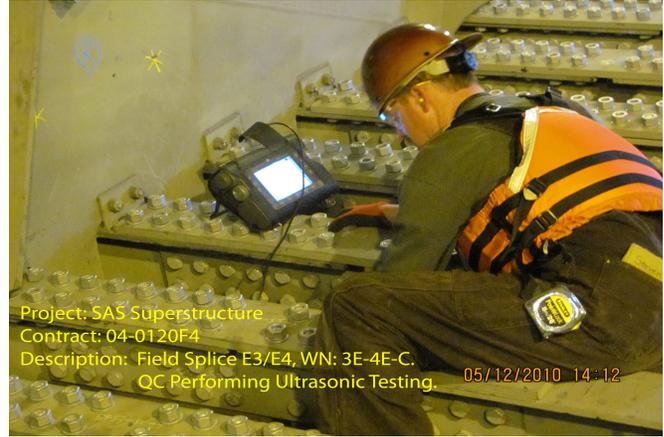
The QAI observed the removal of the backing bar and at the conclusion of the backing bar removal the operator Rory Hogan commence the back gouging on the "B" face of the double-v-groove weld identified as Weld Number (WN): 1W-W2-C. The back gouging and removal of backing bar was performed utilizing the plasma arc cutting method.

The QAI observed the automatic Flux Cored Arc Welding (FCAW-G) of the weld joint identified as Weld Number (WN) 2W-3W-E. The welding was performed by welding personnel Song Tao Huang, ID-3794 utilizing the WPS ABF-D15-3042A-1 Rev. 0. The joint designation appeared to comply with AWS single-v-groove butt joint identified as B-U2a-G. The WPS was also used by the QC inspector Bernie Docena as a reference to monitor and verify the Direct Current Electrode Positive (DCEP) welding parameters which noted and recorded by the QAI as follows: 248 amps, 22.7 volts and a travel speed measured as 230mm per minute. The welding was performed in vertical position (3G) at approximate incline of 22 degrees. The QAI inspector also verified the minimum preheat temperature of 60 degrees Celsius and the maximum interpass temperature of 230 degrees Celsius. Later during the shift the QAI observed, at random intervals, the QC inspector monitoring the in process welding, the surface temperatures and verifying the DCEP welding parameters.

The digital photographs, on page 3 of this report, illustrate the work observed during this scheduled shift.
