DEPARTMENT OF TRANSPORTATION

Contract #: 04-0120F4Cty: SF/ALA Rte: 80 PM: 13.2/13.9File #: 1x.28**WELDING INSPECTION REPORT****Resident Engineer:** Pursell, Gary**Address:** 333 Burma Road**City:** Oakland, CA 94607**Report No:** WIR-013957**Date Inspected:** 10-May-2010**Project Name:** SAS Superstructure**OSM Arrival Time:** 700**Prime Contractor:** American Bridge/Fluor Enterprises, a JV**OSM Departure Time:** 1130**Contractor:** American Bridge/Fluor Enterprises, a JV**Location:** Job Site**CWI Name:** Bonifacio Daquinag Jr.**CWI Present:** Yes No**Inspected CWI report:** Yes No N/A**Rod Oven in Use:** Yes No N/A**Electrode to specification:** Yes No N/A**Weld Procedures Followed:** Yes No N/A**Qualified Welders:** Yes No N/A**Verified Joint Fit-up:** Yes No N/A**Approved Drawings:** Yes No N/A**Approved WPS:** Yes No N/A**Delayed / Cancelled:** Yes No N/A**Bridge No:** 34-0006**Component:** OBG Sections**Summary of Items Observed:**

WELDING INSPECTION REPORT

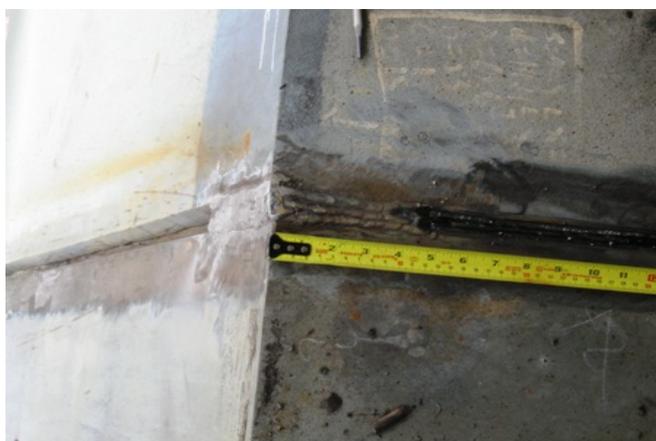
At weld joint E4/E5 – A1 thru A5 this QA Inspector randomly observed ABF welding personnel James Zhen (#6001) and Chun Fai Tsui (#3426) using the Shielded Manual Arc Welding (SMAW) process in the root area of the weld joint. An SMAW welding pass was being placed on each side of weld joint. This QA Inspector randomly observed QC Inspector Bonifacio Daquinag Jr. monitoring the welding. This QA Inspector observed QC Inspector Bonifacio Daquinag Jr. verify the following welding parameters: 158 amperes for James Zhen (#6001) using a 4 mm diameter E7018 electrode and 151 amperes for Chun Fai Tsui (#3426) using a 3.2 mm diameter E7018 electrode. The welding observed appeared to comply with WPS - ABF-WPS-D15-F1200A. While performing verifications this QA Inspector observed the first 120 mm of weld joint E4/E5 – A1, the last 120 mm of weld joint E4/E5 – A5 and approximately 120 mm on both edge plates (B and F) had been welded using the

SMAW process. QC Inspector Bonifacio Daquinag Jr. informed this QA Inspector that ABF personnel had elected not to use weld run off tabs and cascade the Submerged Arc Welding (SAW) passes at each end later filling in any areas with the SMAW process if needed. Please see photo below.
