Contract #: 04-0120F4Cty: SF/ALA Rte: 80 PM: 13.2/13.9File #: 1x.28**WELDING INSPECTION REPORT****Resident Engineer:** Pursell, Gary**Address:** 333 Burma Road**City:** Oakland, CA 94607**Report No:** WIR-013963**Date Inspected:** 10-May-2010**Project Name:** SAS Superstructure**OSM Arrival Time:** 1000**Prime Contractor:** American Bridge/Fluor Enterprises, a JV**OSM Departure Time:** 1830**Contractor:** American Bridge/Fluor Enterprises, a JV**Location:** Job Site**CWI Name:** Jim Cunningham**CWI Present:** Yes No**Inspected CWI report:** Yes No N/A**Rod Oven in Use:** Yes No N/A**Electrode to specification:** Yes No N/A**Weld Procedures Followed:** Yes No N/A**Qualified Welders:** Yes No N/A**Verified Joint Fit-up:** Yes No N/A**Approved Drawings:** Yes No N/A**Approved WPS:** Yes No N/A**Delayed / Cancelled:** Yes No N/A**Bridge No:** 34-0006**Component:** Orthotropic Box Girder**Summary of Items Observed:**

WELDING INSPECTION REPORT

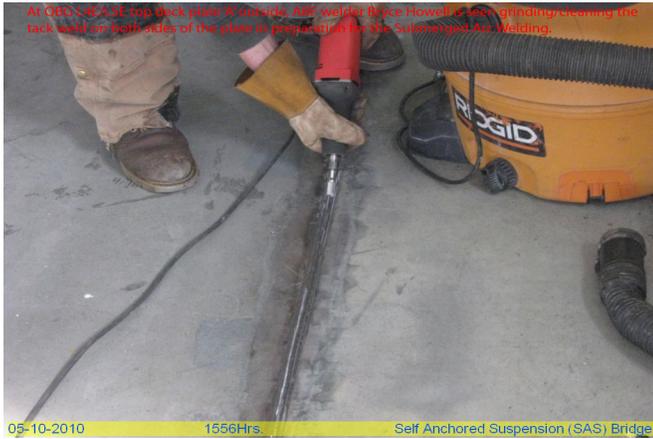
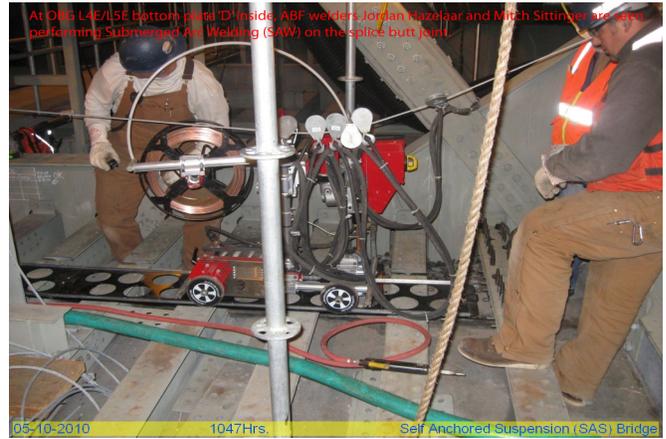
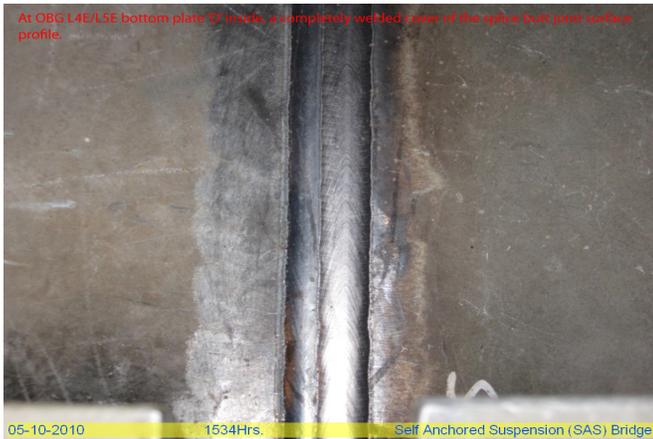
At OBG L3E/L4E plate D1 to D2, two certified ABF welders Mitch Sittinger (ID #0315) and Jordan Hazelaar (ID #2135) were noted performing flat (1G) Submerged Arc Welding (SAW). The welders were utilizing F7A6-EM12K-H8, 3.2mm electrode with corresponding Esab OK Flux 10.62 flux and implementing Caltrans approved Welding Procedure Specification (WPS) ABF-WPS-D15-4042B-1. The plates were preheated to >150 degree Fahrenheit prior welding and the flux were preheated to 380 degree Fahrenheit before use. Welding parameters were monitored by ABF/QC Jim Cunningham. Parameters measured by the ABF QC during welding were 550 amperes, 31.0 volts and 381mm per minute travel speed. QA noted the welding parameters, the workmanship and appearance of the completed fill and cover passes satisfactory and were deemed acceptable to contract requirements. During the shift, the welders have completed welding the 6300mm length of the splice butt joint. The welders have repositioned their track mounted wire feeder/nozzle SAW machine and started welding the North side (1400mm long) where original position of the machine cannot reach. SAW welding at this location was not completed at the end of the shift and the welders will continue tomorrow.

At OBG L4E/L5E top deck plate 'A' outside, welding of the backing bar to both sides of the plates was seen complete. During the shift, three ABF personnel were noted grinding/cleaning the continuous tack weld from end to end of the splice butt joint in preparation for the Submerged Arc Welding to be performed to the joint. Both corners of the deck were also welded 5 inches to the top (deck plate "A") and 5 inches to the side (edge plate 'B')

and 'F').
