Contract #: 04-0120F4Cty: SF/ALA Rte: 80 PM: 13.2/13.9File #: 13.28**WELDING INSPECTION REPORT****Resident Engineer:** Pursell, Gary**Address:** 333 Burma Road**City:** Oakland, CA 94607**Report No:** WIR-013974**Date Inspected:** 11-May-2010**Project Name:** SAS Superstructure**OSM Arrival Time:** 1000**Prime Contractor:** American Bridge/Fluor Enterprises, a JV**OSM Departure Time:** 1830**Contractor:** Oregon Iron Works Clackamas, Or.**Location:** Clackamas, OR

CWI Name:	M. Gregson, J. Salazar, G. Mundt	CWI Present:	Yes	No			
Inspected CWI report:	Yes	No	N/A	Rod Oven in Use:	Yes	No	N/A
Electrode to specification:	Yes	No	N/A	Weld Procedures Followed:	Yes	No	N/A
Qualified Welders:	Yes	No	N/A	Verified Joint Fit-up:	Yes	No	N/A
Approved Drawings:	Yes	No	N/A	Approved WPS:	Yes	No	N/A
				Delayed / Cancelled:	Yes	No	N/A
Bridge No:	34-0006	Component:	Hinge K Pipe Beams

Hinge-K Pipe Beam Assembly 101A-4:

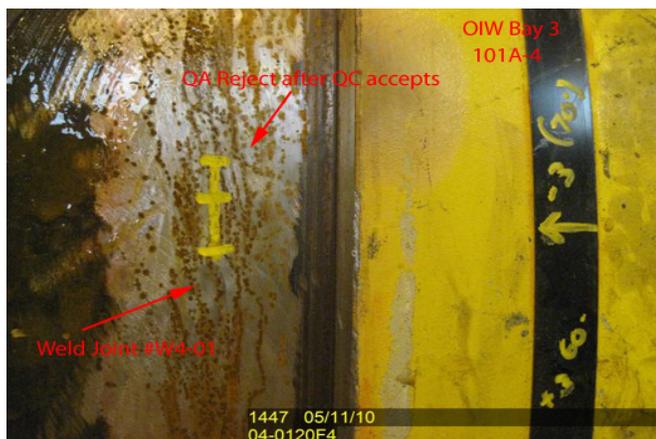
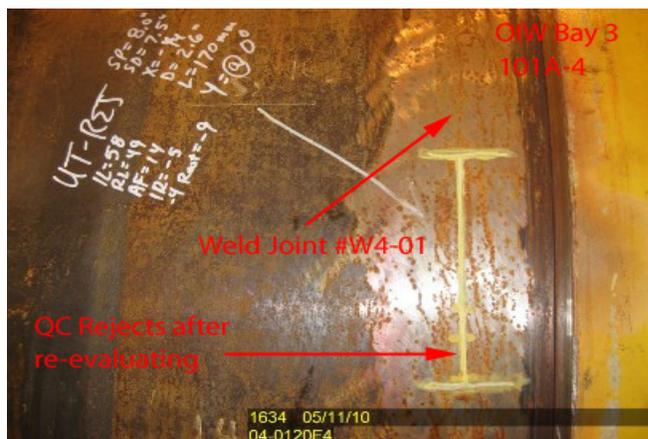
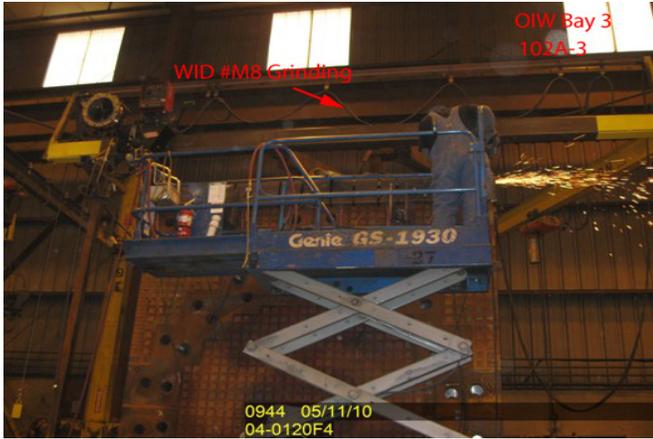
The QA Inspector then randomly performed approximately 10 % Ultrasonic Testing on an area of the weld, which was previously accepted by Lead QC Inspector Mike Gregson. The QA Inspector discovered 1 rejectable indication, which was approximately 170 mm long and determined to be a Class A, per AWS D1.5 Table 6.3, UT Acceptance-Rejection Criteria-Tensile Stress. The QA Inspector informed Lead QC Inspector Mike Gregson of

the rejectable indication and QC Inspector Mike Gregson explained that he will re-evaluate the area. The QA Inspector then observed QC Inspector Gregson perform the testing, utilizing a 70 degree testing angle and Mr. Gregson explained that he could not find the indication. The QA Inspector observed that Mr. Gregson had set up a screen range on his Ultrasonic Testing instrument, which will mask the indication. The QA Inspector advised Mr. Gregson to set up a smaller range to possibly see the indication and then observed Mr. Gregson making changes to his currently set-up screen range and then re-testing the area. The QA Inspector then observed that Mr. Gregson had discovered the indication. Mr. Gregson then agreed with the QA Inspector's testing results and explained that he will instruct swing shift QC Inspector Gary Mundt to also re-evaluate the area.

The QA Inspector was present on this swing shift and observed QC Inspector Mundt performing the UT on the above mentioned area. QC Inspector Mundt explained that he did determine the area was a class A, rejectable indication and he will mark for a weld repair. The QA Inspector later observed that the area was marked, as shown in attached picture below and completed an applicable Ultrasonic Testing Report (TL 6027), on this date.

The QA Inspector was informed by Lead QC Inspector Michael Gregson that the Ultrasonic Testing (UT) on the weld joint, # W4-01, has been completed. The QA Inspector noted that this was a Complete Joint Penetration (CJP), AWS D1.5 B-U7-S, piece mark Fuse 120A-4 to Forging 102A-4. Lead QC Inspector Gregson explained that OIW QC Inspector Gary Mundt had resumed and completed the UT on the previous swing shift and found 1 rejectable and 2 recordable indications. The QA Inspector noted that per AWS D1.5 Sect.6.19.8 "Only those discontinuities which are rejectable need be recorded on the test report, except that for welds designated in the contract documents as being "Fracture Critical," ratings which are up to and including 6dB less critical than rejectability shall be recorded on the test report". Lead QC Inspector Gregson explained that he had verified the indications, which were discovered by QC Inspector Mundt and has agreed with the testing results. Lead QC Inspector Gregson explained that he will generate a appropriate, non-critical Weld Repair Report (WRR) and then present a copy of the report to OIW Production Lead Troy Smith, for repair.
