**DEPARTMENT OF TRANSPORTATION**

Contract #: 04-0120F4Cty: SF/ALA Rte: 80 PM: 13.2/13.9File #: 69.28**WELDING INSPECTION REPORT****Resident Engineer:** Pursell, Gary**Address:** 333 Burma Road**City:** Oakland, CA 94607**Report No:** WIR-014002**Date Inspected:** 11-May-2010**Project Name:** SAS Superstructure**OSM Arrival Time:** 700**Prime Contractor:** American Bridge/Fluor Enterprises, a JV**OSM Departure Time:** 1900**Contractor:** Zhenhua Port Machinery Company, Ltd (ZPMC), Changxing Island **Location:** Shanghai, China**CWI Name:** Jhou Cheng/Liu Fa Wen**CWI Present:** Yes No**Inspected CWI report:** Yes No N/A**Rod Oven in Use:** Yes No N/A**Electrode to specification:** Yes No N/A**Weld Procedures Followed:** Yes No N/A**Qualified Welders:** Yes No N/A**Verified Joint Fit-up:** Yes No N/A**Approved Drawings:** Yes No N/A**Approved WPS:** Yes No N/A**Delayed / Cancelled:** Yes No N/A**Bridge No:** 34-0006**Component:** OBG Components**Summary of Items Observed:**

# WELDING INSPECTION REPORT

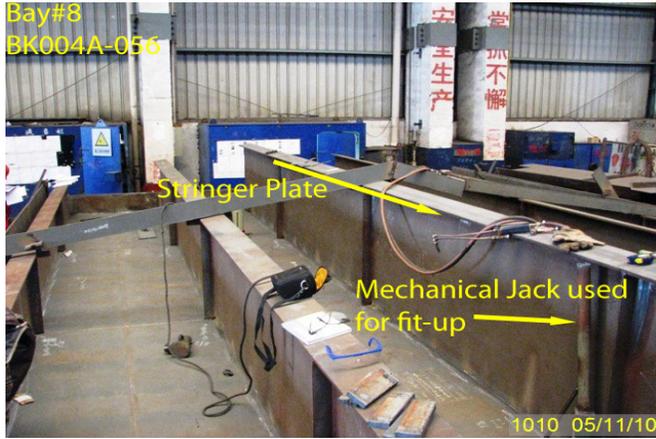
During random in-process inspection of bike path, this QA inspector observed that fit-up of stringer plates to top plate (Bike path-deck plate) was performed by ZPMC personnel. The tack weld was performed by SMAW welding process. This QA inspector observed that ZPMC personnel using mechanical jack for the fit-up to stringer

plates. ZPMC QC was present during observation.  
For further information, please see attached pictures.
