DEPARTMENT OF TRANSPORTATION

Contract #: 04-0120F4Cty: SF/ALA Rte: 80 PM: 13.2/13.9File #: 69.28**WELDING INSPECTION REPORT****Resident Engineer:** Pursell, Gary**Address:** 333 Burma Road**City:** Oakland, CA 94607**Report No:** WIR-014044**Date Inspected:** 14-May-2010**Project Name:** SAS Superstructure**OSM Arrival Time:** 1900**Prime Contractor:** American Bridge/Fluor Enterprises, a JV**OSM Departure Time:** 700**Contractor:** Zhenhua Port Machinery Company, Ltd (ZPMC), Changxing Island **Location:** Shanghai, China

WELDING INSPECTION REPORT

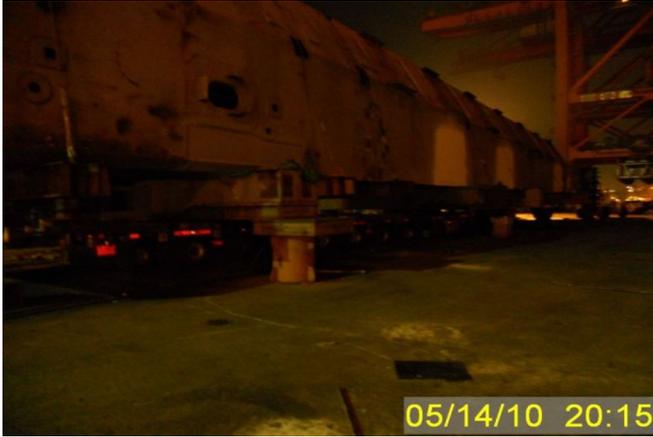
This inspector witnessed ZPMC personnel preparing to move the lift 1 tower sections that are presently lying on the heavy dock to the blast and paint shops.
