**DEPARTMENT OF TRANSPORTATION**

Quality Assurance and Source Inspection

Contract #: 04-0120F4Cty: SF/ALA Rte: 80 PM: 13.2/13.9File #: 69.28**WELDING INSPECTION REPORT****Resident Engineer:** Pursell, Gary**Address:** 333 Burma Road**City:** Oakland, CA 94607**Report No:** WIR-014059**Date Inspected:** 09-May-2010**Project Name:** SAS Superstructure**OSM Arrival Time:** 700**Prime Contractor:** American Bridge/Fluor Enterprises, a JV**OSM Departure Time:** 1900**Contractor:** Zhenhua Port Machinery Company, Ltd (ZPMC), Changxing Island **Location:** Shanghai, China

**Bridge No:** 34-0006**Component:** Orthotropic Box Girder (OBG)**Summary of Items Observed:**

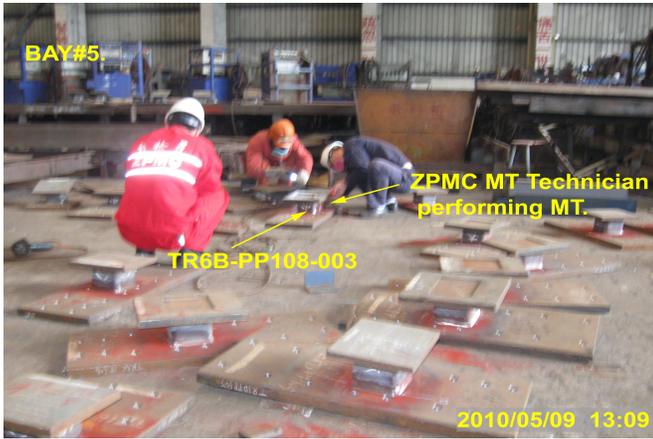
This QA Inspector observed ZPMC MT Technician Mr. Tan Chao wei was performing Magnetic Particle Testing (MT) for the Traveler Rail bracket weld No: TR6B-PP108-003.

Refer attached photo for reference.
