**DEPARTMENT OF TRANSPORTATION**

Contract #: 04-0120F4Cty: SF/ALA Rte: 80 PM: 13.2/13.9File #: 69.28**WELDING INSPECTION REPORT****Resident Engineer:** Pursell, Gary**Address:** 333 Burma Road**City:** Oakland, CA 94607**Report No:** WIR-014146**Date Inspected:** 08-May-2010**Project Name:** SAS Superstructure**OSM Arrival Time:** 700**Prime Contractor:** American Bridge/Fluor Enterprises, a JV**OSM Departure Time:** 1900**Contractor:** Zhenhua Port Machinery Company, Ltd (ZPMC), Changxing Island **Location:** Shanghai, China**CWI Name:** Mr. Qiu Wen/You Qi Guo**CWI Present:** Yes No**Inspected CWI report:** Yes No N/A**Rod Oven in Use:** Yes No N/A**Electrode to specification:** Yes No N/A**Weld Procedures Followed:** Yes No N/A**Qualified Welders:** Yes No N/A**Verified Joint Fit-up:** Yes No N/A**Approved Drawings:** Yes No N/A**Approved WPS:** Yes No N/A**Delayed / Cancelled:** Yes No N/A**Bridge No:** 34-0006**Component:** Tower**Summary of Items Observed:**

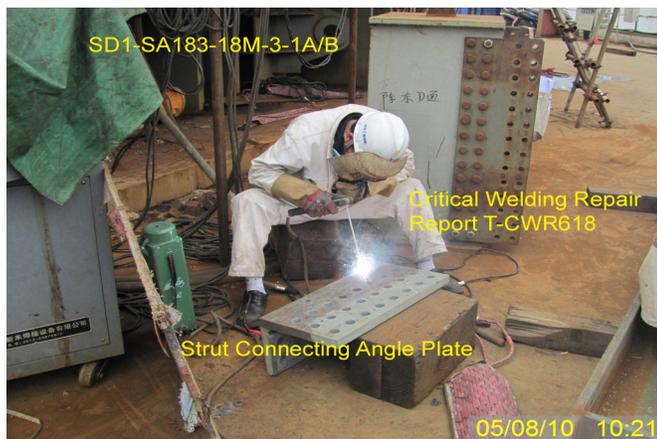
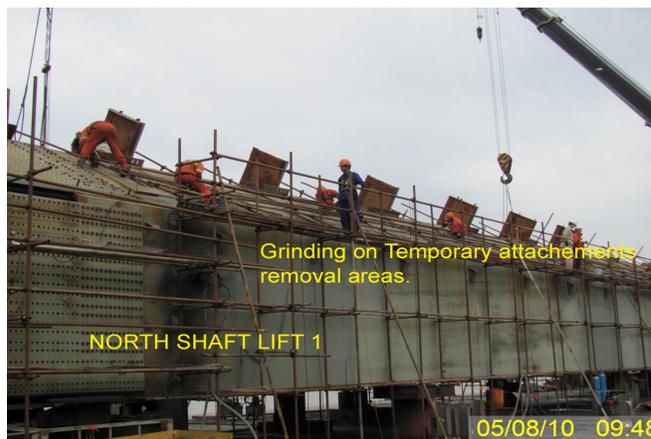
SMAW Welding of weld joint no: SD1-SA183-18M-3-1A/B located on Strut Connecting Angle Plate. Welder is identified as 052910. ZPMC CWI is identified as Mr.You Qi Guo. Welding was been performed against Critical Welding Repair Report T-CWR618 and UT report number- T787-UT-2840.The welding variables recorded by QC appeared to comply with the WPS-485-SMAW-1G(1F)-FCM-Repair-1.Please see the attached photo.
