DEPARTMENT OF TRANSPORTATION

Contract #: 04-0120F4Cty: SF/ALA Rte: 80 PM: 13.2/13.9File #: 69.28**WELDING INSPECTION REPORT****Resident Engineer:** Pursell, Gary**Address:** 333 Burma Road**City:** Oakland, CA 94607**Report No:** WIR-014157**Date Inspected:** 11-May-2010**Project Name:** SAS Superstructure**OSM Arrival Time:** 700**Prime Contractor:** American Bridge/Fluor Enterprises, a JV**OSM Departure Time:** 1900**Contractor:** Zhenhua Port Machinery Company, Ltd (ZPMC), Changxing Island **Location:** Shanghai, China

WELDING INSPECTION REPORT

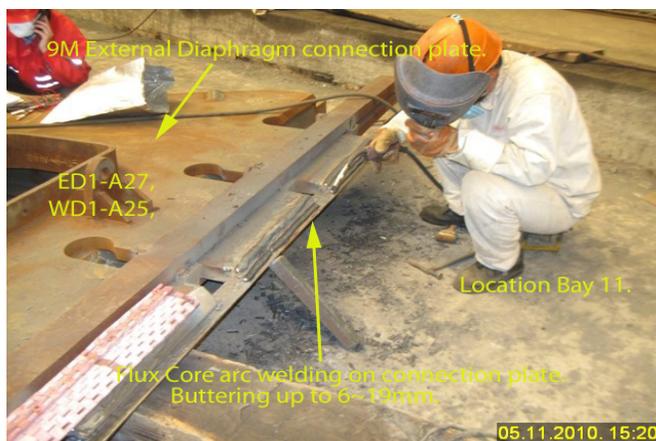
This QA Inspector observed ZPMC qualified welding personnel identified as 049541, 040725. Perform Flux Core Arc Welding (FCAW) on 9M External diaphragm connection plate Buttering up to 6~19mm. Item identified as ED1-A27, WD1-A25. ZPMC QC Identified as Libin with temporary welding repair report, The welding parameters as measured using QC's calibrated instrument appeared to be in general compliance with WPS-345-FCAW-2G(2F)Repair. For more information see below attach photo.

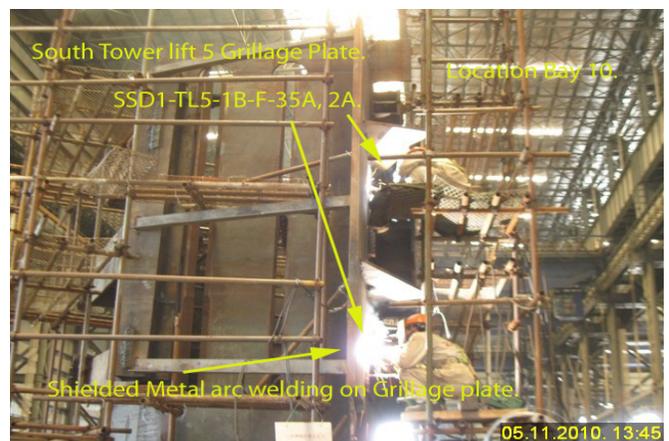
This QA Inspector observed ZPMC qualified welding personnel identified as 500363, 500373. Perform Shielded Metal Arc Welding (SMAW) on South Tower lift 5 Grillage plate. Joint identified as SSD1-TL5-1B/F- 35A, 2A, ZPMC QC Identified as Deng Zhi Beng, The welding parameters as measured using QC's calibrated instrument appeared to be in general compliance with WPS-B-T-3213-B-U3b. For more information see below attach photo.
