DEPARTMENT OF TRANSPORTATION

Contract #: 04-0120F4Cty: SF/ALA Rte: 80 PM: 13.2/13.9File #: 69.28**WELDING INSPECTION REPORT****Resident Engineer:** Pursell, Gary**Address:** 333 Burma Road**City:** Oakland, CA 94607**Report No:** WIR-014283**Date Inspected:** 13-May-2010**Project Name:** SAS Superstructure**OSM Arrival Time:** 700**Prime Contractor:** American Bridge/Fluor Enterprises, a JV**OSM Departure Time:** 1900**Contractor:** Zhenhua Port Machinery Company, Ltd (ZPMC), Changxing Island **Location:** Shanghai, China**CWI Name:** Li Yang**CWI Present:** Yes No**Inspected CWI report:** Yes No N/A**Rod Oven in Use:** Yes No N/A**Electrode to specification:** Yes No N/A**Weld Procedures Followed:** Yes No N/A**Qualified Welders:** Yes No N/A**Verified Joint Fit-up:** Yes No N/A**Approved Drawings:** Yes No N/A**Approved WPS:** Yes No N/A**Delayed / Cancelled:** Yes No N/A**Bridge No:** 34-0006**Component:** Orthotropic Box Girder (OBG)**Summary of Items Observed:**

WELDING INSPECTION REPORT

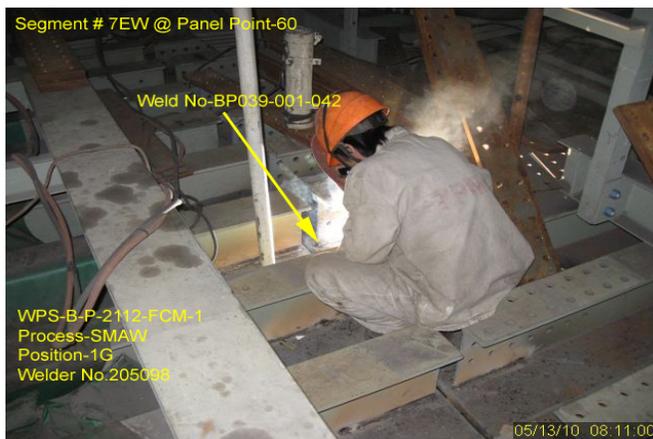
This QA inspector observed ZPMC qualified welding personnel identified as 205098 perform Shielded Metal Welding (SMAW), weld joint identified as BP039-001-042 and was observed welding in the 1G (Flat) positions; ZPMC QC is identified as Mr. Cai Xiao Yeng. The welding parameters measured using QC's calibrated instrument appeared to be in general compliance with WPS-B-P-2112-FCM-1. See the attached Photo.

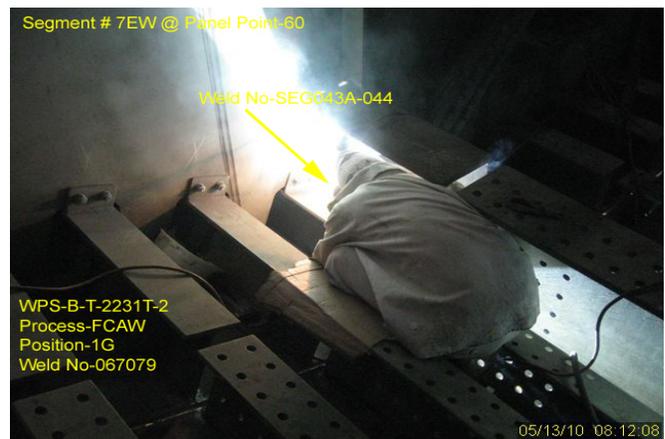
This QA inspector observed ZPMC qualified welding personnel identified as 067079 perform Flux Core Arc Welding (FCAW), weld joint identified as SEG043A-044 and was observed welding in the 1G (Flat) position;. ZPMC QC is identified as Mr.Cai Xiao Yeng. The welding parameters measured using QC's calibrated instrument appeared to be in general compliance with WPS-B-T-2231T-2. See the attached Photo.
