Contract #: 04-0120F4Cty: SF/ALA Rte: 80 PM: 13.2/13.9File #: 69.28**WELDING INSPECTION REPORT****Resident Engineer:** Pursell, Gary**Address:** 333 Burma Road**City:** Oakland, CA 94607**Report No:** WIR-014285**Date Inspected:** 14-May-2010**Project Name:** SAS Superstructure**OSM Arrival Time:** 700**Prime Contractor:** American Bridge/Fluor Enterprises, a JV**OSM Departure Time:** 1900**Contractor:** Zhenhua Port Machinery Company, Ltd (ZPMC), Changxing Island **Location:** Shanghai, China**CWI Name:** Li Yang**CWI Present:** Yes No**Inspected CWI report:** Yes No N/A**Rod Oven in Use:** Yes No N/A**Electrode to specification:** Yes No N/A**Weld Procedures Followed:** Yes No N/A**Qualified Welders:** Yes No N/A**Verified Joint Fit-up:** Yes No N/A**Approved Drawings:** Yes No N/A**Approved WPS:** Yes No N/A**Delayed / Cancelled:** Yes No N/A**Bridge No:** 34-0006**Component:** Orthotropic Box Girder (OBG)**Summary of Items Observed:**

**OBG # TRIAL ASSEMBLY YARD**

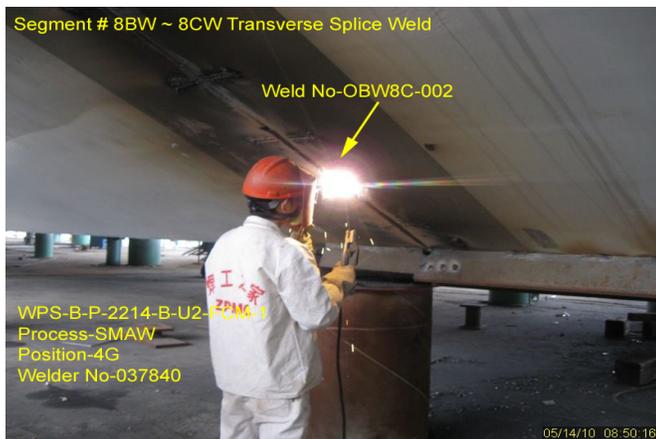
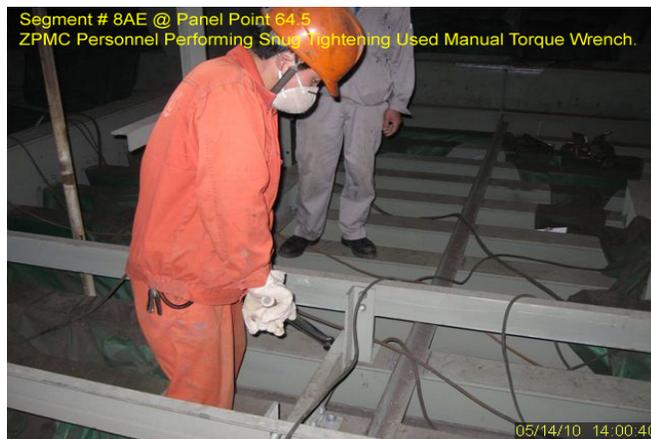
This Quality Assurance (QA) Inspector witnessed final tension verification for Catwalk at Bottom Panel from Panel Point (PP) 61 ~ PP 71 for Segment 8AE ~ 8CE. Inspected 10% on a random basis and found the tension to be in general compliance. Inspection was performed against the Notification No. 00347 Dated May 14, 2010.

Bolt sizes used were M16 x 40 RC Set# DHGM160020 and final torque required was 200 N-m.

Bolt sizes used were M16 x 50 RC Set# DHGM160011 and final torque required was 200 N-m.

Manual Torque wrench was been used with Sr. No. 0900001. Please refer the pictures for more comprehensive detail.

This QA inspector observed ZPMC qualified welding personnel identified as 037840 perform Shielded Metal Arc Welding (SMAW), weld joint identified as OBW8C-002 and was observed welding in the 4G (Overhead) position; ZPMC QC is identified as Mr.Zhang Hai Tao. The welding parameters measured using QC's calibrated instrument appeared to be in general compliance with WPS-B-P-2214-B-U2-FCM-1. See the attached below Photo.
