**DEPARTMENT OF TRANSPORTATION**

Contract #: 04-0120F4Cty: SF/ALA Rte: 80 PM: 13.2/13.9File #: 1.28**WELDING INSPECTION REPORT****Resident Engineer:** Pursell, Gary**Address:** 333 Burma Road**City:** Oakland, CA 94607**Report No:** WIR-014313**Date Inspected:** 21-May-2010**Project Name:** SAS Superstructure**OSM Arrival Time:** 800**Prime Contractor:** American Bridge/Fluor Enterprises, a JV**OSM Departure Time:** 1630**Contractor:** American Bridge/Fluor Enterprises, a JV**Location:** Job Site

**Bridge No:** 34-0006**Summary of Items Observed:**

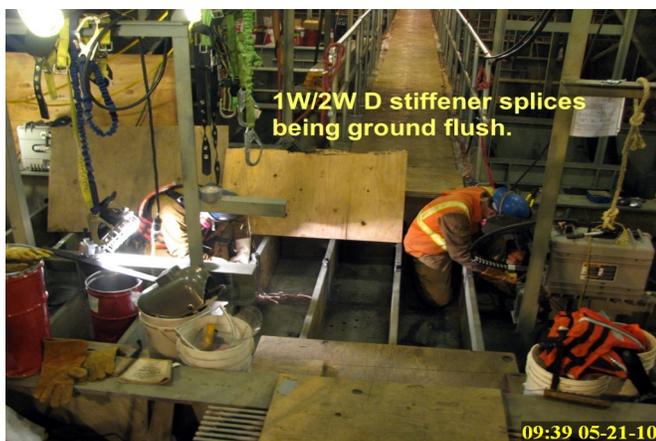
1) The QAI observed ABF personnel grinding the outside cover passes on plate F at OBG lifts 1W/2W field splice.

The QAI noted that the Quality Control (QC) Inspector William Sherwood is present at this location. The QAI noted that the work is being performed by Jordan Hazelaar, ID 2135. The QAI was informed that the welding on this side was finished and was being ground flush and smooth. The QAI was also informed that the backing bar removal and back welding will not be done during this shift. See the attached photo.
