Contract #: 04-0120F4Cty: SF/ALA Rte: 80 PM: 13.2/13.9File #: 1x.28**WELDING INSPECTION REPORT****Resident Engineer:** Pursell, Gary**Address:** 333 Burma Road**City:** Oakland, CA 94607**Report No:** WIR-014329**Date Inspected:** 20-May-2010**Project Name:** SAS Superstructure**OSM Arrival Time:** 1230**Prime Contractor:** American Bridge/Fluor Enterprises, a JV**OSM Departure Time:** 1600**Contractor:** American Bridge/Fluor Enterprises, a JV**Location:** Job Site**CWI Name:** Bernard Docena**CWI Present:** Yes No**Inspected CWI report:** Yes No N/A**Rod Oven in Use:** Yes No N/A**Electrode to specification:** Yes No N/A**Weld Procedures Followed:** Yes No N/A**Qualified Welders:** Yes No N/A**Verified Joint Fit-up:** Yes No N/A**Approved Drawings:** Yes No N/A**Approved WPS:** Yes No N/A**Delayed / Cancelled:** Yes No N/A**Bridge No:** 34-0006**Component:** OBG Sections**Summary of Items Observed:**

WELDING INSPECTION REPORT

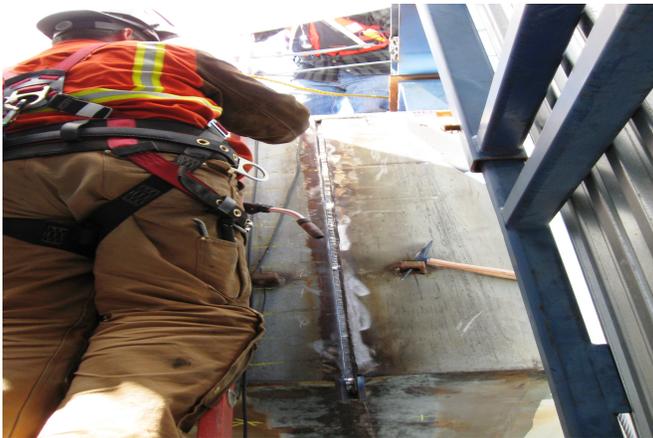
At weld joint W1/W2-F this QA Inspector randomly observed ABF welding personnel Mitch Sittinger (#0315) was performing production welding using the FCAW process. This QA Inspector performed a verification of the welding parameters and observed the following: 230 amperes and 23.5 volts with a travel speed of 190 mm per minute. This QA Inspector randomly observed QC Inspector Tony Sherwood monitoring the welding parameters and performing visual inspections of the various weld passes. The welding parameters observed appeared to

comply with the Welding Procedure Specification (WPS) ABF-WPS-D15-3040A-3. The welding and QC functions observed this date appeared to comply with the contract requirements. Please see general photo below of the work area.
