Contract #: 04-0120F4Cty: SF/ALA Rte: 80 PM: 13.2/13.9File #: 69.28**WELDING INSPECTION REPORT****Resident Engineer:** Pursell, Gary**Address:** 333 Burma Road**City:** Oakland, CA 94607**Report No:** WIR-014337**Date Inspected:** 23-May-2010**Project Name:** SAS Superstructure**OSM Arrival Time:** 700**Prime Contractor:** American Bridge/Fluor Enterprises, a JV**OSM Departure Time:** 1900**Contractor:** Zhenhua Port Machinery Company, Ltd (ZPMC), Changxing Island **Location:** Shanghai, China**CWI Name:** Li Yang**CWI Present:** Yes No**Inspected CWI report:** Yes No N/A**Rod Oven in Use:** Yes No N/A**Electrode to specification:** Yes No N/A**Weld Procedures Followed:** Yes No N/A**Qualified Welders:** Yes No N/A**Verified Joint Fit-up:** Yes No N/A**Approved Drawings:** Yes No N/A**Approved WPS:** Yes No N/A**Delayed / Cancelled:** Yes No N/A**Bridge No:** 34-0006**Component:** OBG**Summary of Items Observed:**

OBG SEGMENT 7CW

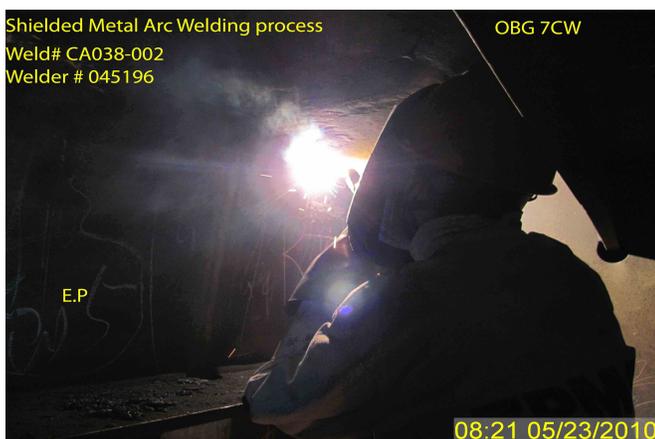
This Quality Assurance (QA) Inspector observed ZPMC qualified welder 062092 performing Shielded Metal Arc Welding process for weld DP709A-008 located on PCMK. Weld between "I" rib and deck panel. ZPMC QC Mr. Liu Hua Jie monitoring this welding. The welding variables recorded by QC appeared to comply with the WPS-B-T-4114-1.
