Quality Assurance and Source Inspection

Contract #: 04-0120F4Cty: SF/ALA Rte: 80 PM: 13.2/13.9File #: 69.28**WELDING INSPECTION REPORT****Resident Engineer:** Pursell, Gary**Address:** 333 Burma Road**City:** Oakland, CA 94607**Report No:** WIR-014339**Date Inspected:** 25-May-2010**Project Name:** SAS Superstructure**OSM Arrival Time:** 700**Prime Contractor:** American Bridge/Fluor Enterprises, a JV**OSM Departure Time:** 1900**Contractor:** Zhenhua Port Machinery Company, Ltd (ZPMC), Changxing Island **Location:** Shanghai, China**CWI Name:** Li Yang**CWI Present:** Yes No**Inspected CWI report:** Yes No N/A**Rod Oven in Use:** Yes No N/A**Electrode to specification:** Yes No N/A**Weld Procedures Followed:** Yes No N/A**Qualified Welders:** Yes No N/A**Verified Joint Fit-up:** Yes No N/A**Approved Drawings:** Yes No N/A**Approved WPS:** Yes No N/A**Delayed / Cancelled:** Yes No N/A**Bridge No:** 34-0006**Component:** OBG**Summary of Items Observed:**

TRIAL ASSEMBLY YARD

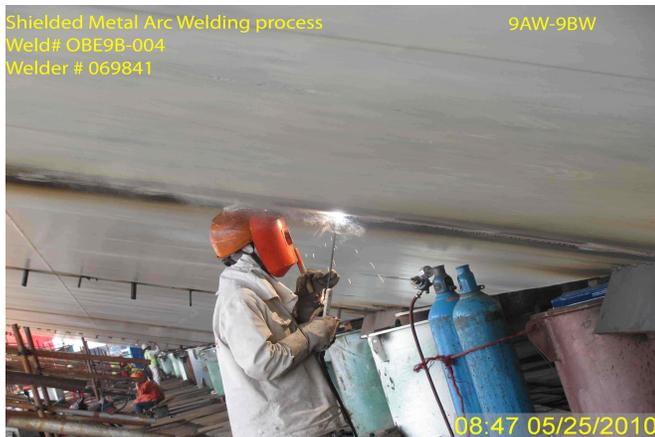
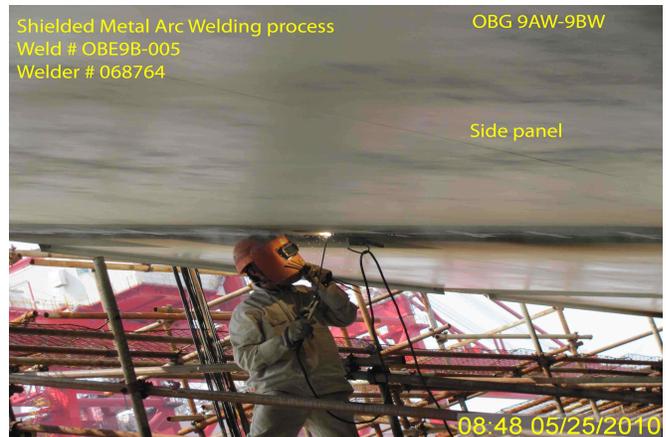
Unless otherwise noted, all work observed on this dated appeared to generally comply with applicable contract documents.
