Contract #: 04-0120F4Cty: SF/ALA Rte: 80 PM: 13.2/13.9File #: 69.28**WELDING INSPECTION REPORT****Resident Engineer:** Pursell, Gary**Address:** 333 Burma Road**City:** Oakland, CA 94607**Report No:** WIR-014390**Date Inspected:** 26-May-2010**Project Name:** SAS Superstructure**OSM Arrival Time:** 700**Prime Contractor:** American Bridge/Fluor Enterprises, a JV**OSM Departure Time:** 1900**Contractor:** Zhenhua Port Machinery Company, Ltd (ZPMC), Changxing Island **Location:** Shanghai, China**CWI Name:** Li Yang**CWI Present:** Yes No**Inspected CWI report:** Yes No N/A**Rod Oven in Use:** Yes No N/A**Electrode to specification:** Yes No N/A**Weld Procedures Followed:** Yes No N/A**Qualified Welders:** Yes No N/A**Verified Joint Fit-up:** Yes No N/A**Approved Drawings:** Yes No N/A**Approved WPS:** Yes No N/A**Delayed / Cancelled:** Yes No N/A**Bridge No:** 34-0006**Component:** OBG**Summary of Items Observed:**

TRIAL ASSEMBLY YARD

OBG SEGMENT 8BE

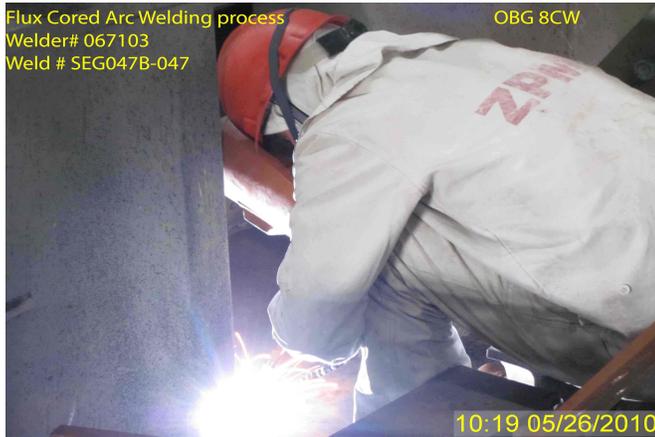
Unless otherwise noted, all work observed on this dated appeared to generally comply with applicable contract

documents.
