DEPARTMENT OF TRANSPORTATION

Contract #: 04-0120F4Cty: SF/ALA Rte: 80 PM: 13.2/13.9File #: 69.28**WELDING INSPECTION REPORT****Resident Engineer:** Pursell, Gary**Address:** 333 Burma Road**City:** Oakland, CA 94607**Report No:** WIR-014401**Date Inspected:** 23-May-2010**Project Name:** SAS Superstructure**OSM Arrival Time:** 700**Prime Contractor:** American Bridge/Fluor Enterprises, a JV**OSM Departure Time:** 1900**Contractor:** Zhenhua Port Machinery Company, Ltd (ZPMC), Changxing Island **Location:** Shanghai, China

WELDING INSPECTION REPORT

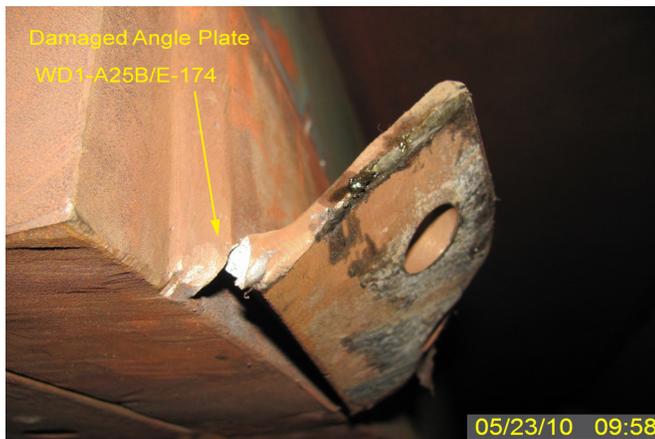
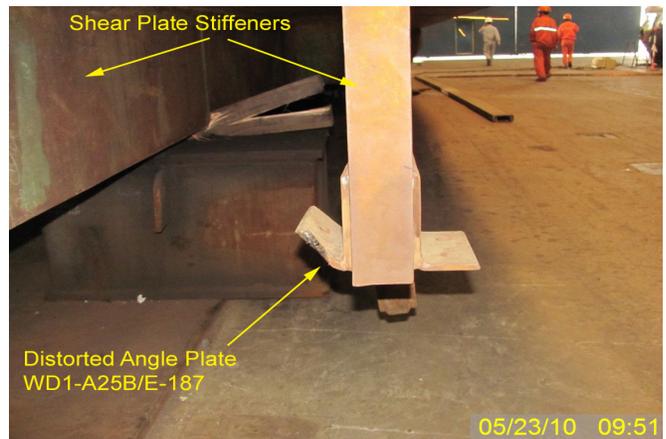
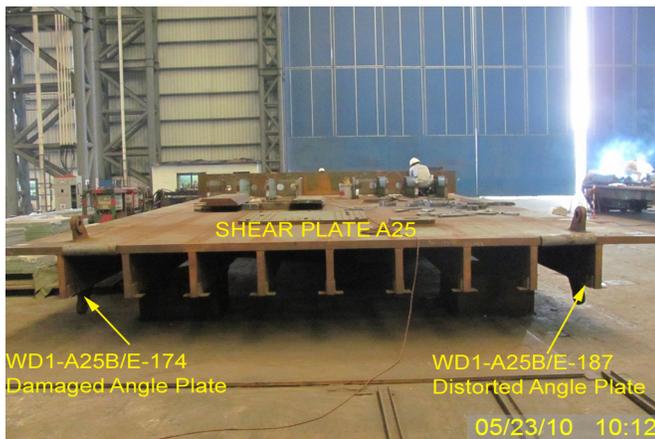
During random visual inspection in Bay 11, this Quality Assurance Inspector (QA) discovered the following issue:

- Two (2) angle plates in the top elevation of Shear Plate were damaged and distorted.
- The welds are identified as WD1-A25B/E-174,187; fillet weld.
- Tower Lift 1 Shear Plate WD1-A25.
- The member is located in Bay#11.
- These angle plates were previously VT and MT tested.
- The Notice of Witness Inspection Number (NWIT) is 005762.

For further information, please see the attached pictures:

The incident report is issued for the above mentioned discrepancy observed in Bay#11 and prior to issue it was informed to ZPMC QC and ABF QA.
