DEPARTMENT OF TRANSPORTATION

Quality Assurance and Source Inspection

Contract #: 04-0120F4Cty: SF/ALA Rte: 80 PM: 13.2/13.9File #: 69.28**WELDING INSPECTION REPORT****Resident Engineer:** Pursell, Gary**Address:** 333 Burma Road**City:** Oakland, CA 94607**Report No:** WIR-014413**Date Inspected:** 21-May-2010**Project Name:** SAS Superstructure**OSM Arrival Time:** 700**Prime Contractor:** American Bridge/Fluor Enterprises, a JV**OSM Departure Time:** 1600**Contractor:** Zhenhua Port Machinery Company, Ltd (ZPMC), Changxing Island **Location:** Shanghai, China**CWI Name:** You Qi Guo.**CWI Present:** Yes No**Inspected CWI report:** Yes No N/A**Rod Oven in Use:** Yes No N/A**Electrode to specification:** Yes No N/A**Weld Procedures Followed:** Yes No N/A**Qualified Welders:** Yes No N/A**Verified Joint Fit-up:** Yes No N/A**Approved Drawings:** Yes No N/A**Approved WPS:** Yes No N/A**Delayed / Cancelled:** Yes No N/A**Bridge No:** 34-0006**Component:** Tower**Summary of Items Observed:**

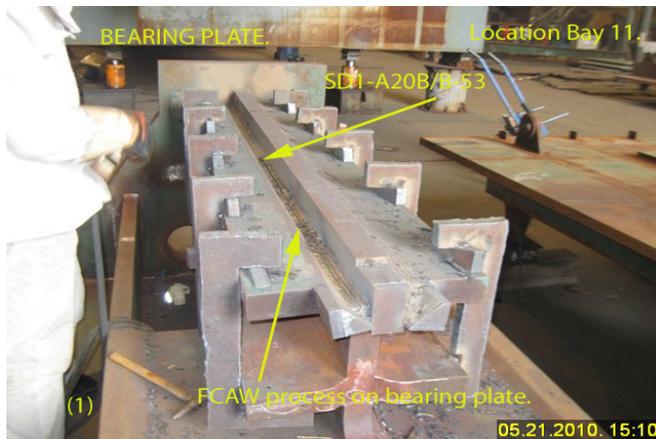
This QA Inspector observed ZPMC qualified welding personnel identified as 053486, Perform Flux Core Arc Welding (FCAW) on Shear plate bearing stiffener weld. Joint identified as SD1-A20B/B-53. ZPMC QC Identified as Xu Jie. The welding parameters as measured using QC's calibrated instrument appeared to be in general compliance with WPS-B-T-2331-Tc-P4-F. For more information see below attach photo number 1.

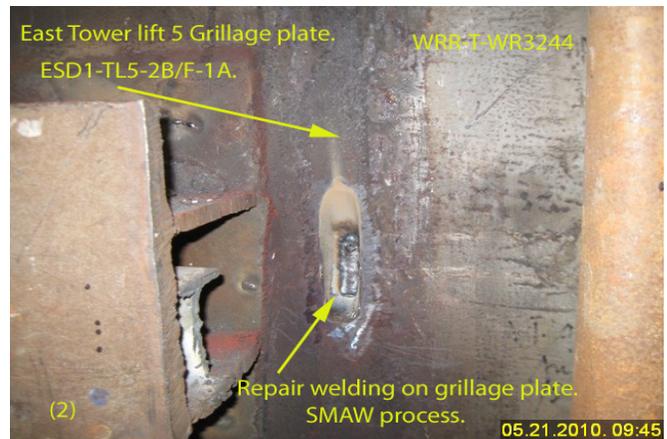
This QA Inspector observed ZPMC qualified welding personnel identified as 040655, Perform Shielded Metal Arc Welding (SMAW) on East tower lift 5 grillage plate. Joint identified as ESD1-TL5-2B/F-1A, ZPMC QC Identified as Libin with Temporary welding repair report WRR-T-WR3244. The welding parameters as measured using QC's calibrated instrument appeared to be in general compliance with WPS-485-SMAW-3G (3F) Repair-1. For more information see below attach photo number 2.
