Contract #: 04-0120F4Cty: SF/ALA Rte: 80 PM: 13.2/13.9File #: 69.28**WELDING INSPECTION REPORT****Resident Engineer:** Pursell, Gary**Address:** 333 Burma Road**City:** Oakland, CA 94607**Report No:** WIR-014495**Date Inspected:** 30-May-2010**Project Name:** SAS Superstructure**OSM Arrival Time:** 700**Prime Contractor:** American Bridge/Fluor Enterprises, a JV**OSM Departure Time:** 1900**Contractor:** Zhenhua Port Machinery Company, Ltd (ZPMC), Changxing Island **Location:** Shanghai, China**CWI Name:** Li Yang**CWI Present:** Yes No**Inspected CWI report:** Yes No N/A**Rod Oven in Use:** Yes No N/A**Electrode to specification:** Yes No N/A**Weld Procedures Followed:** Yes No N/A**Qualified Welders:** Yes No N/A**Verified Joint Fit-up:** Yes No N/A**Approved Drawings:** Yes No N/A**Approved WPS:** Yes No N/A**Delayed / Cancelled:** Yes No N/A**Bridge No:** 34-0006**Component:** OBG**Summary of Items Observed:**

On this day CALTRANS OSM Quality Assurance Inspector (QA) Shrikant Utekar was present during the times noted above for observations relative to the fabrication of the SAS Superstructure being performed by Zhenhua Port Machinery Company (ZPMC) at Changxing Island in Shang

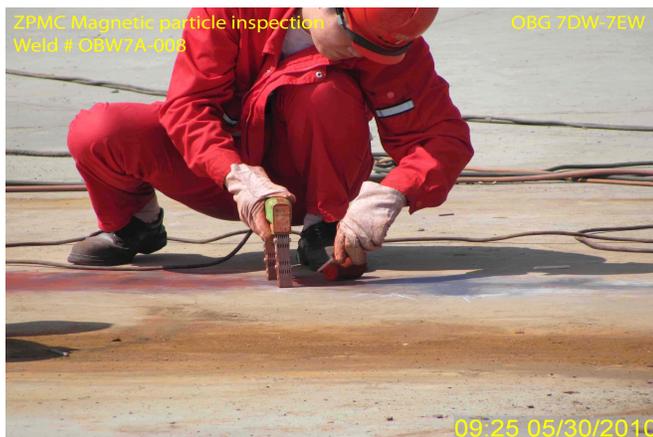
This QA Inspector observed ZPMC QA Inspector performing magnetic particle inspection for the deck panel splice weld between OBG segment 7DW and 7EW (OBW7A-008). See attached photo.
