**DEPARTMENT OF TRANSPORTATION**

Contract #: 04-0120F4Cty: SF/ALA Rte: 80 PM: 13.2/13.9File #: 69.28**WELDING INSPECTION REPORT****Resident Engineer:** Pursell, Gary**Address:** 333 Burma Road**City:** Oakland, CA 94607**Report No:** WIR-014575**Date Inspected:** 26-May-2010**Project Name:** SAS Superstructure**OSM Arrival Time:** 700**Prime Contractor:** American Bridge/Fluor Enterprises, a JV**OSM Departure Time:** 1900**Contractor:** Zhenhua Port Machinery Company, Ltd (ZPMC), Changxing Island **Location:** Shanghai, China**CWI Name:** Mr. An Qing Xiang**CWI Present:** Yes No**Inspected CWI report:** Yes No N/A**Rod Oven in Use:** Yes No N/A**Electrode to specification:** Yes No N/A**Weld Procedures Followed:** Yes No N/A**Qualified Welders:** Yes No N/A**Verified Joint Fit-up:** Yes No N/A**Approved Drawings:** Yes No N/A**Approved WPS:** Yes No N/A**Delayed / Cancelled:** Yes No N/A**Bridge No:** 34-0006**Component:** Tower**Summary of Items Observed:**

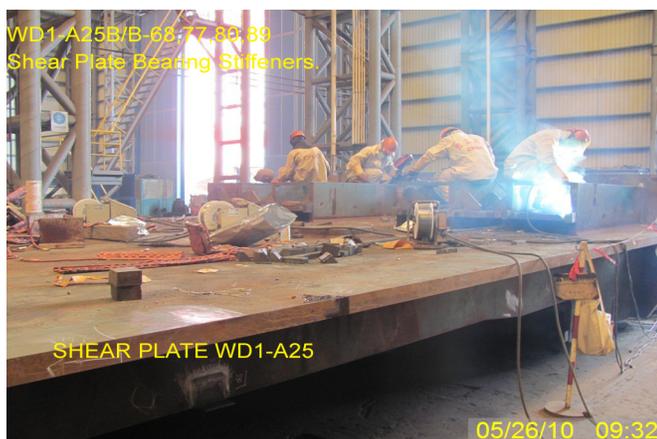
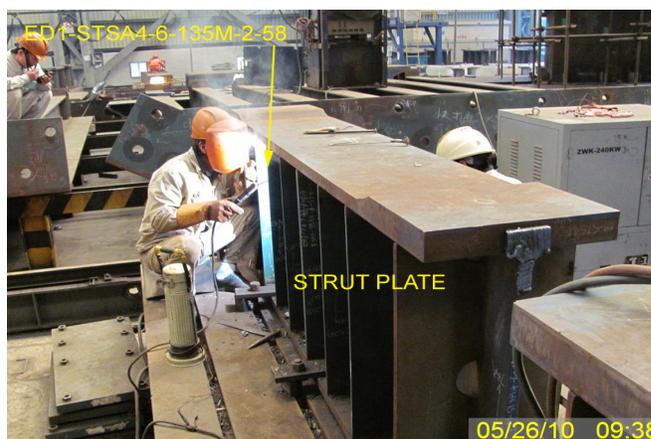
Unless otherwise noted, all work observed on this date appeared to generally comply with the applicable contract documents.
