Contract #: 04-0120F4Cty: SF/ALA Rte: 80 PM: 13.2/13.9File #: 69.28**WELDING INSPECTION REPORT****Resident Engineer:** Pursell, Gary**Address:** 333 Burma Road**City:** Oakland, CA 94607**Report No:** WIR-014578**Date Inspected:** 29-May-2010**Project Name:** SAS Superstructure**OSM Arrival Time:** 700**Prime Contractor:** American Bridge/Fluor Enterprises, a JV**OSM Departure Time:** 1900**Contractor:** Zhenhua Port Machinery Company, Ltd (ZPMC), Changxing Island **Location:** Shanghai, China

WELDING INSPECTION REPORT

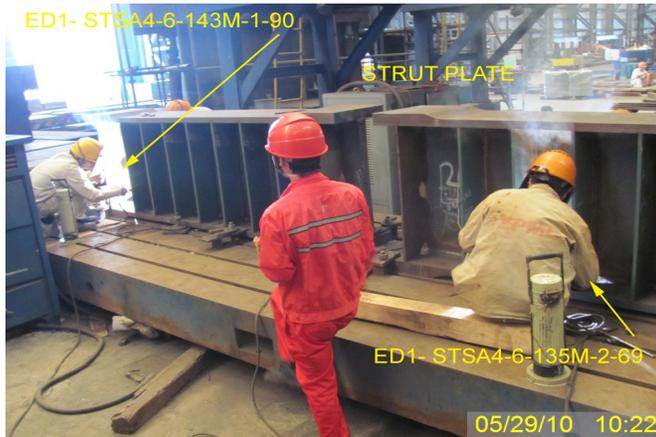
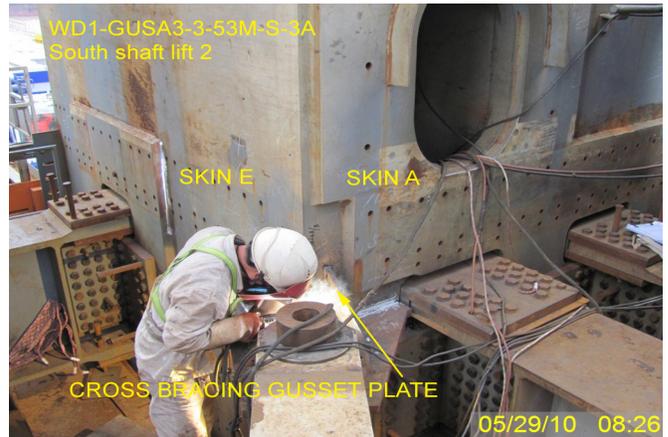
Unless otherwise noted, all work observed on this date appeared to generally comply with the applicable contract documents.
