Contract #: 04-0120F4Cty: SF/ALA Rte: 80 PM: 13.2/13.9File #: 13.28**WELDING INSPECTION REPORT****Resident Engineer:** Pursell, Gary**Address:** 333 Burma Road**City:** Oakland, CA 94607**Report No:** WIR-014617**Date Inspected:** 08-Jun-2010**Project Name:** SAS Superstructure**OSM Arrival Time:** 1000**Prime Contractor:** American Bridge/Fluor Enterprises, a JV**OSM Departure Time:** 1830**Contractor:** Oregon Iron Works Clackamas, Or.**Location:** Clackamas, OR

**Bridge No:** 34-0006**Component:** Hinge K Pipe Beams**Summary of Items Observed:**

**Hinge-K Pipe Beam Assembly 101A-3:**

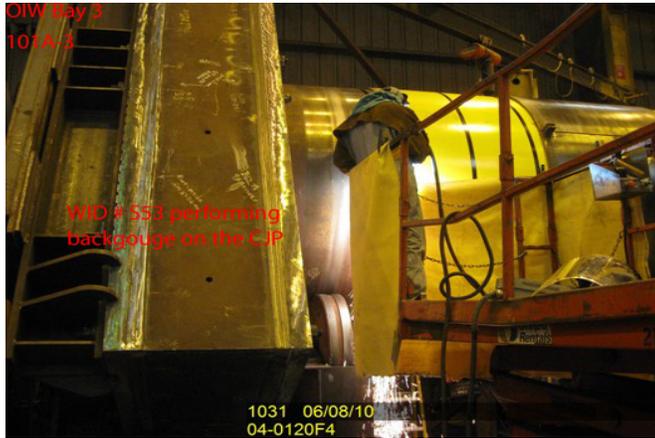
The QA Inspector observed WID #S53 (Jerry Shephard), performing the backgouge on the Weld Joint #W4-01. The QA Inspector observed that this Complete Joint Penetration (AWS D1.5 B-U7-S), was the Fuse 120A-3 to Forging 102A-3 and that OIW QC Inspector Jose' Salazar was present, during this shift. QC Inspector Salazar explained that prior to the backgouging, he had verified a pre-heat temperature of approximately 150 degrees Fahrenheit (66 C). The QA Inspector noted that the interior portion of the weld had been previously completed and that the backgouging being performed was from the exterior, to clean the root pass to sound metal. The QA Inspector observed that WID #S53 was performing the backgouge utilizing the Carbon Arc process and was performing this from a scissor lift and that the Assembly was slowly rotating, for ease of performing the backgouge. The QA Inspector randomly verified pre-heat temperature to be in compliance with the minimum 150 degrees Fahrenheit. The QA Inspector spoke with QC Inspector Jose' Salazar and QC Inspector Salazar explained that the Carbon Arcing will remove most of the material and then a grinder will be utilized, to remove the remaining material. The QA Inspector noted that with the backgouging of the previous assemblies, OIW had utilized a hand held grinder with an attached 9" disc. The QA Inspector observed that the backgouging continued throughout the end of the shift.

perform the backgouging, utilizing the carbon Arc process, on the above mentioned Weld Joint. The QA Inspector observed that OIW QC Inspector Gary Mundt was present and QC Inspector Mundt explained that he had verified the minimum pre-heat temperature of 150 degrees Fahrenheit. The QA Inspector then randomly observed WID #V7, perform a check with a 150 degree Fahrenheit Tempilstick indicator. QC Inspector Mundt explained that the backgouging will continue throughout the shift.
