DEPARTMENT OF TRANSPORTATION

Contract #: 04-0120F4Cty: SF/ALA Rte: 80 PM: 13.2/13.9File #: 69.28**WELDING INSPECTION REPORT****Resident Engineer:** Pursell, Gary**Address:** 333 Burma Road**City:** Oakland, CA 94607**Report No:** WIR-014814**Date Inspected:** 15-Jun-2010**Project Name:** SAS Superstructure**OSM Arrival Time:** 700**Prime Contractor:** American Bridge/Fluor Enterprises, a JV**OSM Departure Time:** 1900**Contractor:** Zhenhua Port Machinery Company, Ltd (ZPMC), Changxing Island **Location:** Shanghai, China**CWI Name:** Li Yang**CWI Present:** Yes No**Inspected CWI report:** Yes No N/A**Rod Oven in Use:** Yes No N/A**Electrode to specification:** Yes No N/A**Weld Procedures Followed:** Yes No N/A**Qualified Welders:** Yes No N/A**Verified Joint Fit-up:** Yes No N/A**Approved Drawings:** Yes No N/A**Approved WPS:** Yes No N/A**Delayed / Cancelled:** Yes No N/A**Bridge No:** 34-0006**Component:** OBG**Summary of Items Observed:**

WELDING INSPECTION REPORT

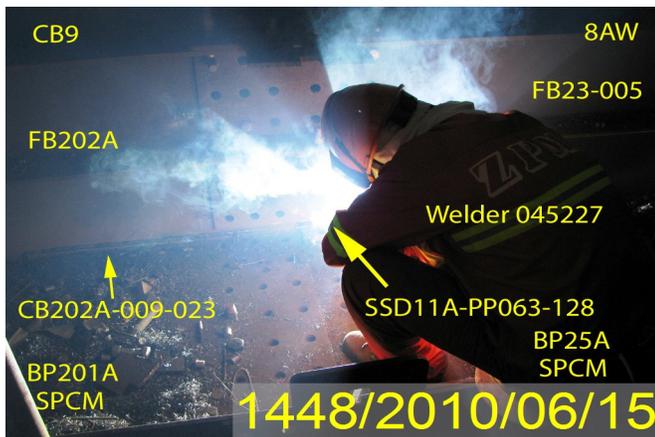
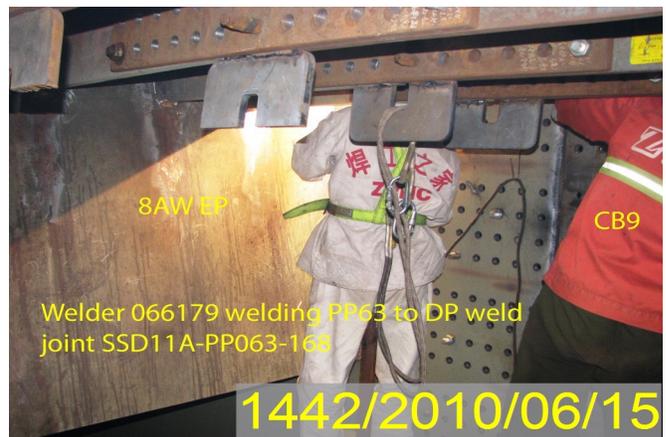
During random in-process visual inspection at Segments 8AW/8BW+CB9 cross beam side of segments, this QA Inspector observed 3 welders welding at various locations without a CWI present on 6-15-10 (1400~1500) work shift. This QA Inspector issued an incident report for noted issue for today's work shift.
