Contract #: 04-0120F4Cty: SF/ALA Rte: 80 PM: 13.2/13.9File #: 69.28**WELDING INSPECTION REPORT****Resident Engineer:** Pursell, Gary**Address:** 333 Burma Road**City:** Oakland, CA 94607**Report No:** WIR-014817**Date Inspected:** 07-May-2010**Project Name:** SAS Superstructure**OSM Arrival Time:** 700**Prime Contractor:** American Bridge/Fluor Enterprises, a JV**OSM Departure Time:** 1900**Contractor:** Zhenhua Port Machinery Company, Ltd (ZPMC), Changxing Island **Location:** Shanghai, China**CWI Name:** Li Yang**CWI Present:** Yes No**Inspected CWI report:** Yes No N/A**Rod Oven in Use:** Yes No N/A**Electrode to specification:** Yes No N/A**Weld Procedures Followed:** Yes No N/A**Qualified Welders:** Yes No N/A**Verified Joint Fit-up:** Yes No N/A**Approved Drawings:** Yes No N/A**Approved WPS:** Yes No N/A**Delayed / Cancelled:** Yes No N/A**Bridge No:** 34-0006**Component:** OBG Segment**Summary of Items Observed:**

OBG # TRIAL ASSEMBLY YARD

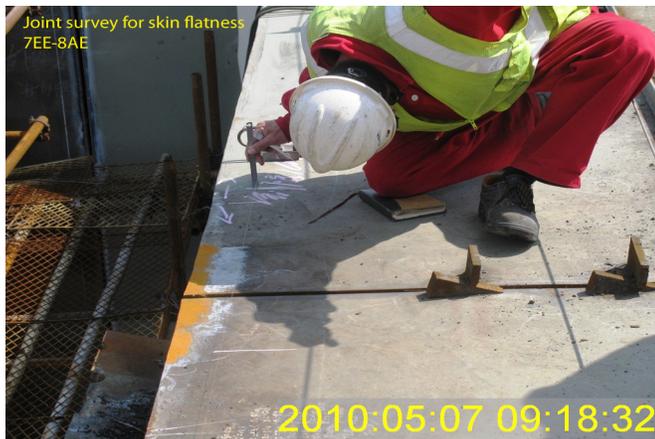
This QA Inspector performed dimensional survey for the Skin Flatness across Transverse Splice Joints at Location B1, B2, B3, B4, T1 and T2 for Segment 7EE to 8AE along with ABF using 5M string line, 600mm and 630mm

straight edge. Reports forwarded to team leader for further action. Please find the attached picture below.
