**DEPARTMENT OF TRANSPORTATION**

Contract #: 04-0120F4Cty: SF/ALA Rte: 80 PM: 13.2/13.9File #: 69.28**WELDING INSPECTION REPORT****Resident Engineer:** Pursell, Gary**Address:** 333 Burma Road**City:** Oakland, CA 94607**Report No:** WIR-014849**Date Inspected:** 15-May-2010**Project Name:** SAS Superstructure**OSM Arrival Time:** 1900**Prime Contractor:** American Bridge/Fluor Enterprises, a JV**OSM Departure Time:** 700**Contractor:** Zhenhua Port Machinery Company, Ltd (ZPMC), Changxing Island **Location:** Shanghai, China**CWI Name:** See Below**CWI Present:** Yes No**Inspected CWI report:** Yes No N/A**Rod Oven in Use:** Yes No N/A**Electrode to specification:** Yes No N/A**Weld Procedures Followed:** Yes No N/A**Qualified Welders:** Yes No N/A**Verified Joint Fit-up:** Yes No N/A**Approved Drawings:** Yes No N/A**Approved WPS:** Yes No N/A**Delayed / Cancelled:** Yes No N/A**Bridge No:** 34-0006**Component:** OBG and Tower**Summary of Items Observed:**

**OBG Bay 14**

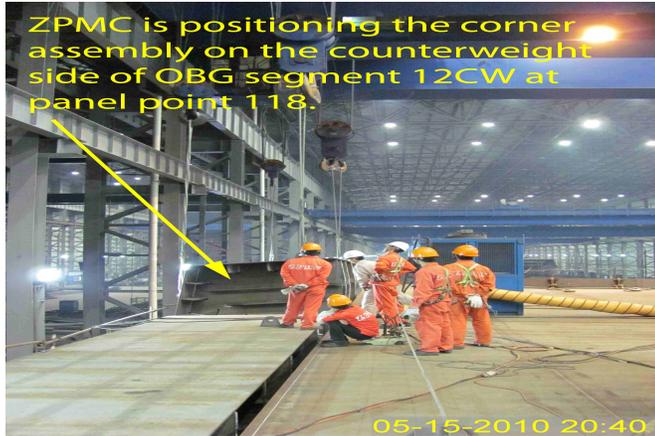
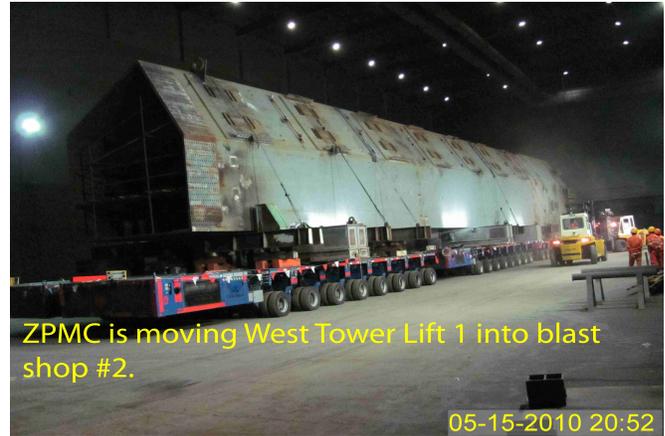
This QA Inspector observed ZPMC workers using one of the overhead cranes to position a corner assembly in position on the counterweight side of OBG segment 12C at panel point 118. See the photographs below for additional information.
