**DEPARTMENT OF TRANSPORTATION**

Contract #: 04-0120F4Cty: SF/ALA Rte: 80 PM: 13.2/13.9File #: 69.28**WELDING INSPECTION REPORT****Resident Engineer:** Pursell, Gary**Address:** 333 Burma Road**City:** Oakland, CA 94607**Report No:** WIR-014855**Date Inspected:** 22-May-2010**Project Name:** SAS Superstructure**OSM Arrival Time:** 1900**Prime Contractor:** American Bridge/Fluor Enterprises, a JV**OSM Departure Time:** 700**Contractor:** Zhenhua Port Machinery Company, Ltd (ZPMC), Changxing Island **Location:** Shanghai, China**CWI Name:** See Below**CWI Present:** Yes No**Inspected CWI report:** Yes No N/A**Rod Oven in Use:** Yes No N/A**Electrode to specification:** Yes No N/A**Weld Procedures Followed:** Yes No N/A**Qualified Welders:** Yes No N/A**Verified Joint Fit-up:** Yes No N/A**Approved Drawings:** Yes No N/A**Approved WPS:** Yes No N/A**Delayed / Cancelled:** Yes No N/A**Bridge No:** 34-0006**Component:** OBG**Summary of Items Observed:**

## WELDING INSPECTION REPORT

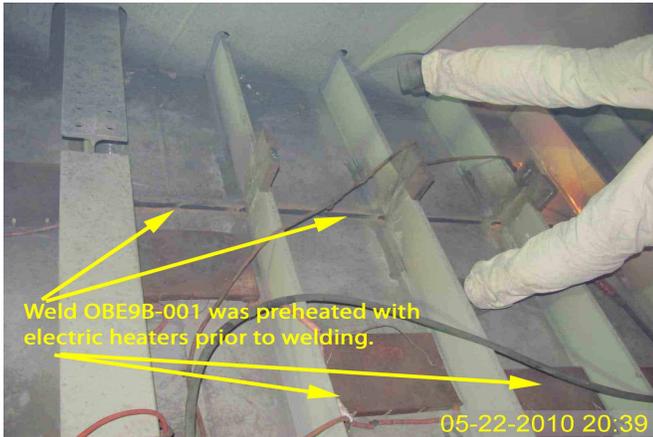
This QA Inspector observed ZPMC welder Mr. Yu Hui Ye, stencil 045143 is using flux cored welding procedure WPS-B-T-2232-TC-U4b-F-2 to make traveler rail mounting plate welds TR1B-PP53-001 and TR1B-PP53-002. This QA Inspector measured a welding current of approximately 290 amps and 30.0 volts. This QA Inspector observed that Mr. Yu Hui Ye appears to be certified to make this weld. Items observed on this date appeared to

generally comply with applicable contract documents.
