Contract #: 04-0120F4Cty: SF/ALA Rte: 80 PM: 13.2/13.9File #: 69.28**WELDING INSPECTION REPORT****Resident Engineer:** Pursell, Gary**Address:** 333 Burma Road**City:** Oakland, CA 94607**Report No:** WIR-014867**Date Inspected:** 05-Jun-2010**Project Name:** SAS Superstructure**OSM Arrival Time:** 1900**Prime Contractor:** American Bridge/Fluor Enterprises, a JV**OSM Departure Time:** 700**Contractor:** Zhenhua Port Machinery Company, Ltd (ZPMC), Changxing Island **Location:** Shanghai, China**CWI Name:** See Below**CWI Present:** Yes No**Inspected CWI report:** Yes No N/A**Rod Oven in Use:** Yes No N/A**Electrode to specification:** Yes No N/A**Weld Procedures Followed:** Yes No N/A**Qualified Welders:** Yes No N/A**Verified Joint Fit-up:** Yes No N/A**Approved Drawings:** Yes No N/A**Approved WPS:** Yes No N/A**Delayed / Cancelled:** Yes No N/A**Bridge No:** 34-0006**Component:** OBG**Summary of Items Observed:**

**OBG Segment Trial Assembly**

## WELDING INSPECTION REPORT

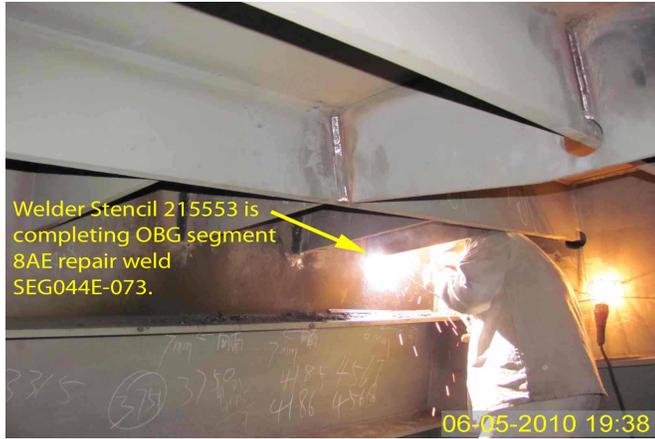
This QA Inspector observed ZPMC welder Mr. Yang Yunfeng, stencil 215553 is using shielded metal welding procedure WPS-345-SMAW-3G(3F)-Repair to make OBG stiffener plate weld SEG044E-073 which was identified as being misaligned on weld repair document B-WR-13262. This weld is located between OBG segment 8AE panel points PP63.5 and PP64 on the cross beam side deck plate. This QA Inspector observed Mr.

Yang Yunfeng appears to be certified to make this weld. This QA Inspector measured a welding current of approximately 170 amps and the base material appears to have been preheated with a torch prior to welding. Items observed on this date appeared to generally comply with applicable contract documents. See the photograph below for additional information.
