Contract #: 04-0120F4Cty: SF/ALA Rte: 80 PM: 13.2/13.9File #: 69.28**WELDING INSPECTION REPORT****Resident Engineer:** Pursell, Gary**Address:** 333 Burma Road**City:** Oakland, CA 94607**Report No:** WIR-014873**Date Inspected:** 12-Jun-2010**Project Name:** SAS Superstructure**OSM Arrival Time:** 1900**Prime Contractor:** American Bridge/Fluor Enterprises, a JV**OSM Departure Time:** 700**Contractor:** Zhenhua Port Machinery Company, Ltd (ZPMC), Changxing Island **Location:** Shanghai, China**CWI Name:** See Below**CWI Present:** Yes No**Inspected CWI report:** Yes No N/A**Rod Oven in Use:** Yes No N/A**Electrode to specification:** Yes No N/A**Weld Procedures Followed:** Yes No N/A**Qualified Welders:** Yes No N/A**Verified Joint Fit-up:** Yes No N/A**Approved Drawings:** Yes No N/A**Approved WPS:** Yes No N/A**Delayed / Cancelled:** Yes No N/A**Bridge No:** 34-0006**Component:** OBG**Summary of Items Observed:**

OBG Segment Trial Assembly

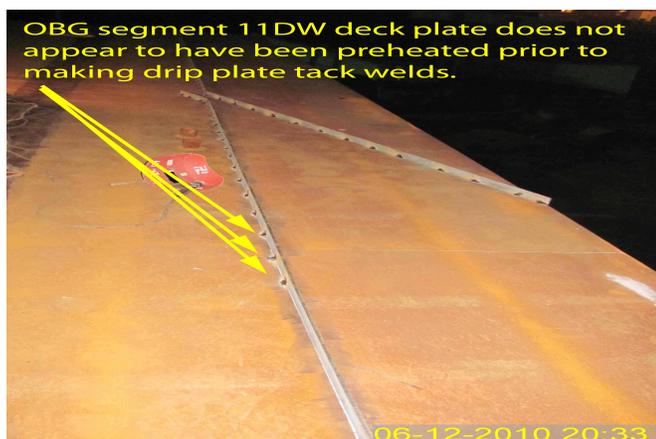
This QA Inspector observed ZPMC welder Mr. Jiang Shizhen, stencil 48694 is using shielded metal arc process to make tack welds between drip plates and the top deck plate on OBG segment 11DW near panel point PP106. This QA Inspector initially observed this welding from approximately 50 meters away from the OBG segment and when this QA Inspector climbed to the top deck approximately two minutes later this QA Inspector observed the

base material adjacent to where the most recent tack weld had been made appears to be at an ambient temperature. No other welding appears to be taking place near this OBG segment and no ZPMC QC personnel were observed in the area. This QA Inspector observed Mr. Jiang Shizhen appears to be certified to make this weld. Mr. Jiang Shizhen observed this QA Inspector measuring the base material temperature and Mr. Jiang Shizhen stopped additional welding and he removed his welding equipment from OBG segment 11DW the top deck plate. Items observed on this date do not fully appear to comply with applicable contract documents. See the photograph below for additional information.
