Contract #: 04-0120F4Cty: SF/ALA Rte: 80 PM: 13.2/13.9File #: 69.28**WELDING INSPECTION REPORT****Resident Engineer:** Pursell, Gary**Address:** 333 Burma Road**City:** Oakland, CA 94607**Report No:** WIR-015139**Date Inspected:** 26-Jun-2010**Project Name:** SAS Superstructure**OSM Arrival Time:** 700**Prime Contractor:** American Bridge/Fluor Enterprises, a JV**OSM Departure Time:** 1700**Contractor:** Zhenhua Port Machinery Company, Ltd (ZPMC), Changxing Island **Location:** Shanghai, China

Bridge No: 34-0006**Component:** OBG**Summary of Items Observed:**

WELDING INSPECTION REPORT

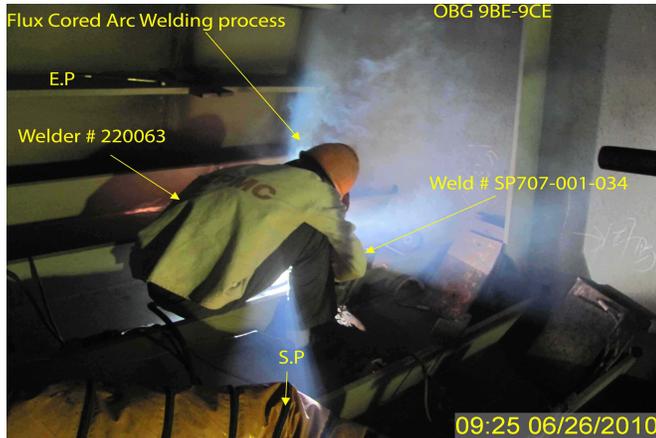
This Quality Assurance (QA) Inspector observed ZPMC qualified welder 220063 performing Flux Cored Arc Welding process for weld 034 located on PCMK SP707-001. ZPMC QC Mr. Wang Li Yang monitoring this welding. The welding variables recorded by QC appeared to comply with the WPS-B-T-2233-b-u2-f.

This Quality Assurance (QA) Inspector observed ZPMC qualified welder 222396 performing Flux Cored Arc Welding process for weld 048 located on PCMK SP373-001. ZPMC QC Mr. Wang Li Yang monitoring this welding. The welding variables recorded by QC appeared to comply with the WPS-B-T-2233-b-u2-f.

This Quality Assurance (QA) Inspector observed ZPMC qualified welder 220067 performing Flux Cored Arc Welding process for weld 056 located on PCMK SP689-001. ZPMC QC Mr. Wang Li Yang monitoring this welding. The welding variables recorded by QC appeared to comply with the WPS-B-T-2233-b-u2-f.

This Quality Assurance (QA) Inspector observed ZPMC qualified welder 053753 performing Shielded Metal Arc Welding process for weld 004 located on PCMK OBE9B. ZPMC QC Mr. Anqing Xiang monitoring this welding. The welding variables recorded by QC appeared to comply with the WPS-345-SMAW-3G (3F)-FCM-Repair-1.
