DEPARTMENT OF TRANSPORTATION

Quality Assurance and Source Inspection

Contract #: 04-0120F4Cty: SF/ALA Rte: 80 PM: 13.2/13.9File #: 69.28**WELDING INSPECTION REPORT****Resident Engineer:** Pursell, Gary**Address:** 333 Burma Road**City:** Oakland, CA 94607**Report No:** WIR-015163**Date Inspected:** 19-Jun-2010**Project Name:** SAS Superstructure**OSM Arrival Time:** 700**Prime Contractor:** American Bridge/Fluor Enterprises, a JV**OSM Departure Time:** 1900**Contractor:** Zhenhua Port Machinery Company, Ltd (ZPMC), Changxing Island **Location:** Shanghai, China**CWI Name:** Mr. Chen Xi**CWI Present:** Yes No**Inspected CWI report:** Yes No N/A**Rod Oven in Use:** Yes No N/A**Electrode to specification:** Yes No N/A**Weld Procedures Followed:** Yes No N/A**Qualified Welders:** Yes No N/A**Verified Joint Fit-up:** Yes No N/A**Approved Drawings:** Yes No N/A**Approved WPS:** Yes No N/A**Delayed / Cancelled:** Yes No N/A**Bridge No:** 34-0006**Component:** Orthotropic Box Girder (OBG)**Summary of Items Observed:**

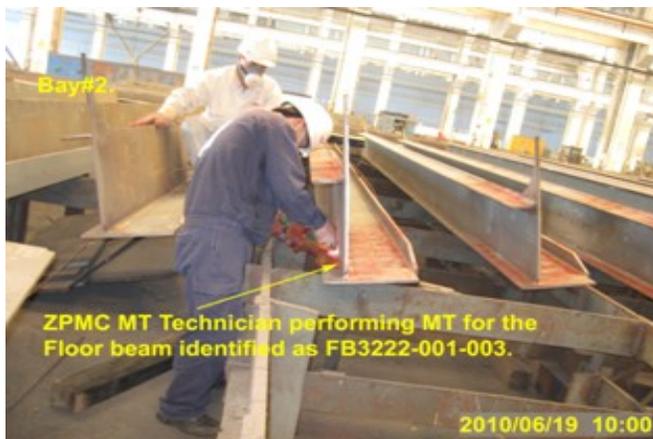
ZPMC MT Technician was performing Magnetic Particle Testing (MT) for the Floor beam weld joint are identified as FB3222-001-003/004/006.Refer attached photos for reference.
