**DEPARTMENT OF TRANSPORTATION**

Contract #: 04-0120F4Cty: SF/ALA Rte: 80 PM: 13.2/13.9File #: 69.28**WELDING INSPECTION REPORT****Resident Engineer:** Pursell, Gary**Address:** 333 Burma Road**City:** Oakland, CA 94607**Report No:** WIR-015361**Date Inspected:** 02-Jul-2010**Project Name:** SAS Superstructure**OSM Arrival Time:** 700**Prime Contractor:** American Bridge/Fluor Enterprises, a JV**OSM Departure Time:** 1900**Contractor:** Zhenhua Port Machinery Company, Ltd (ZPMC), Changxing Island **Location:** Shanghai, China**CWI Name:** Le Zhi Jiang**CWI Present:** Yes No**Inspected CWI report:** Yes No N/A**Rod Oven in Use:** Yes No N/A**Electrode to specification:** Yes No N/A**Weld Procedures Followed:** Yes No N/A**Qualified Welders:** Yes No N/A**Verified Joint Fit-up:** Yes No N/A**Approved Drawings:** Yes No N/A**Approved WPS:** Yes No N/A**Delayed / Cancelled:** Yes No N/A**Bridge No:** 34-0006**Component:** Orthotropic Box Girder (OBG)**Summary of Items Observed:**

**OBG # BAY 3**

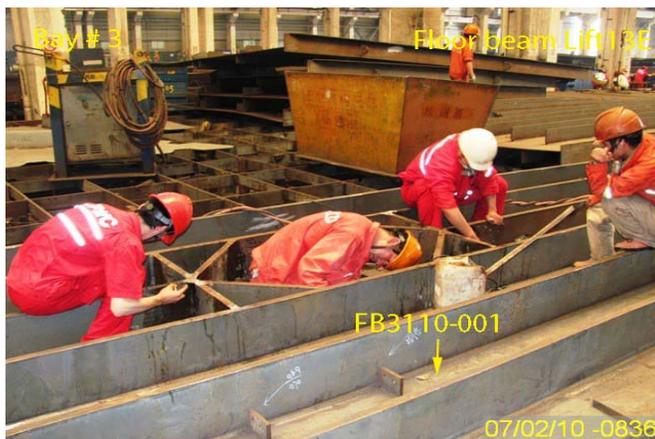
During in process visual inspection, this QA inspector observed ZPMC Ultrasonic Testing (UT) technicians perform UT on various weld joints. See attached pictures.
